Arundo Removal and Replacement Team 2019 Monitoring Report

CDFW File #: 1#: #1600-2018-0287-R3

Arundo Removal and Replacement Team

2019 Monitoring Report

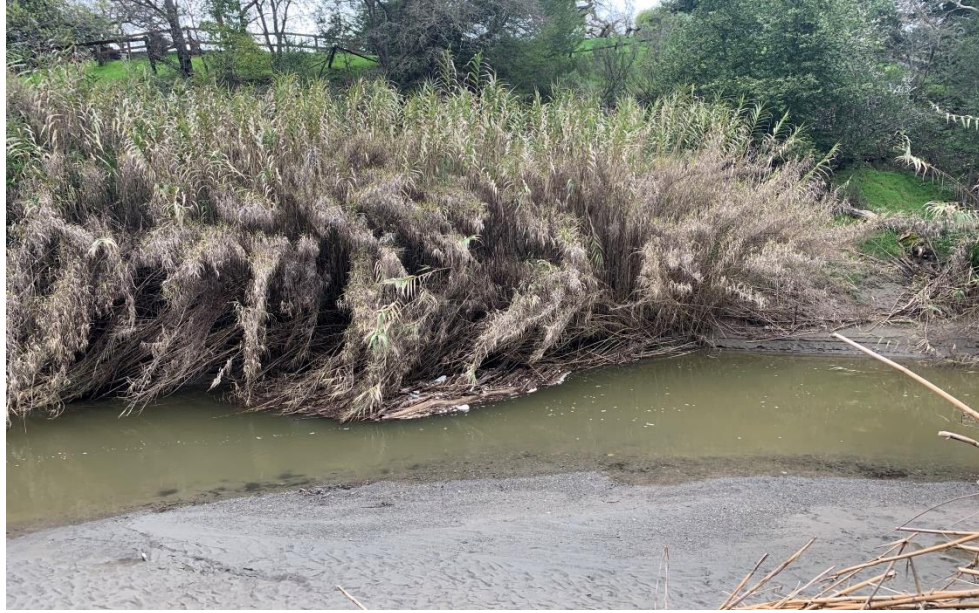
View 1. San Ramon Creek site in June 2018. Note the large Arundo stand at the site center.

In 2018, the Arundo stand had been cleared by volunteers and Trust contractors. No herbicide spray was used on the Arundo, and the stand grew back to its original height (though not the same high density) quickly. In early December 2019, the stand was cut and all the non-native vegetation on site was cleared (View 2) and placed in a dumpster.

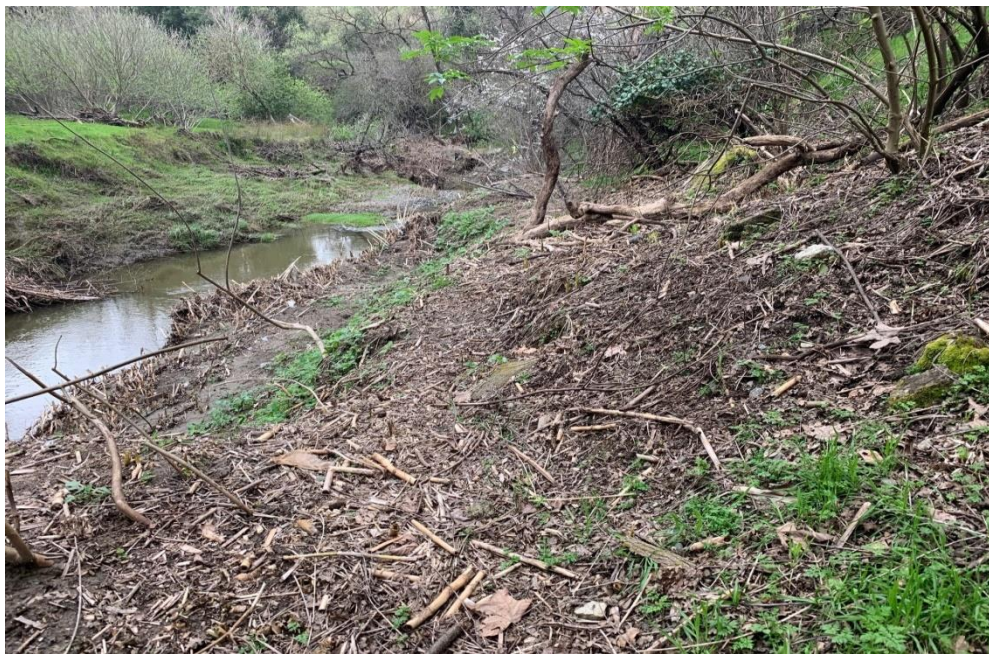
View 2. San Ramon Creek site in December 2019, following clearance of Arundo and other invasive plants.

Shortly after the Arundo was cut and cleared in December, the Arundo stubs were sprayed with a 41% solution of glyphosate to control reemergence. In mid-December, 20 community volunteers planted almost 5,000 plugs: 2,000 valley sedge plants and 3,000 creeping wild rye plants. The terrace at the top of the site was densely planted with creeping wild rye, and the steep slopes below were planted in scattered clumps with the sedge.

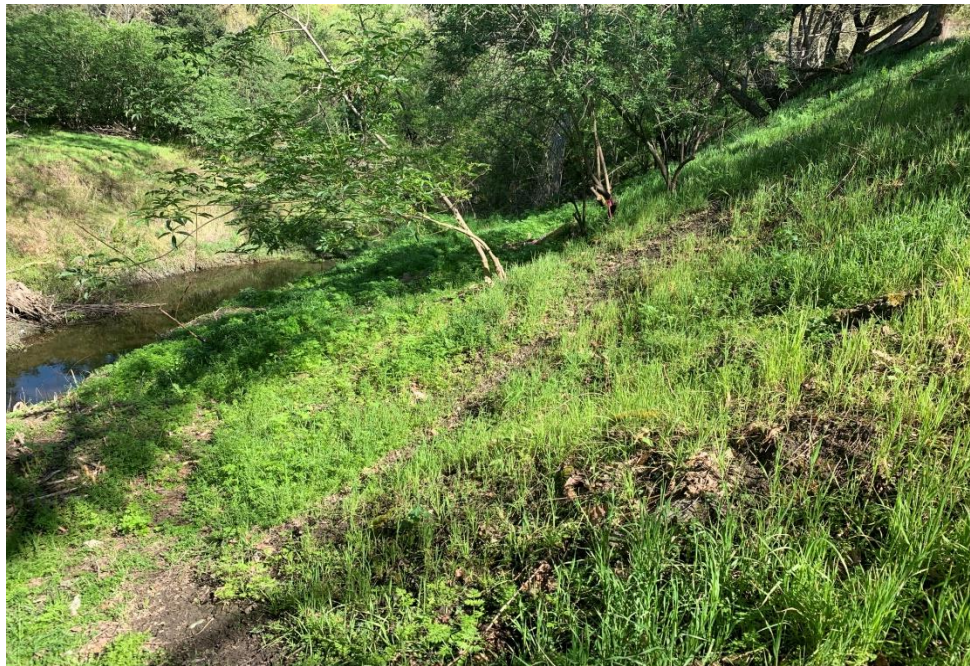
View 3. San Ramon Creek site in March 2020 with dense growth of planted plugs and some weeds throughout site. Creeping wild rye is prominent in the foreground.

Initial plug growth was significant, helped by late spring rains (View 3). However, as of June, the non-native annual grasses, especially ripgut brome (*Bromus diandrus*), had become the dominant plant on-site, providing for high absolute cover and high cover by exotics (non-native species that are not considered highly invasive). Creeping wild rye grows in patches and singly throughout the upper third of the site with valley sedge scattered in the lower two-thirds, but they provide relatively low absolute cover overall. The competition with the grasses has clearly worked against the native plantings. Cover by invasives, especially compared to the baseline, is very low. Dick Heron of the FSRC has followed up on the Arundo and sprayed a number of the resprouts.

Overall, removal and almost complete eradication of the invasives has been successful—the Arundo has resprouted but is being controlled, and the other invasives are insignificant. This site does have relatively low cover by natives compared to Walnut Creek and Lafayette Creek though, probably due to the competition with the non-native grasses. The ARRT should consider replanting this site with additional native plants and using a pre-emergent herbicide to control the annual exotics.

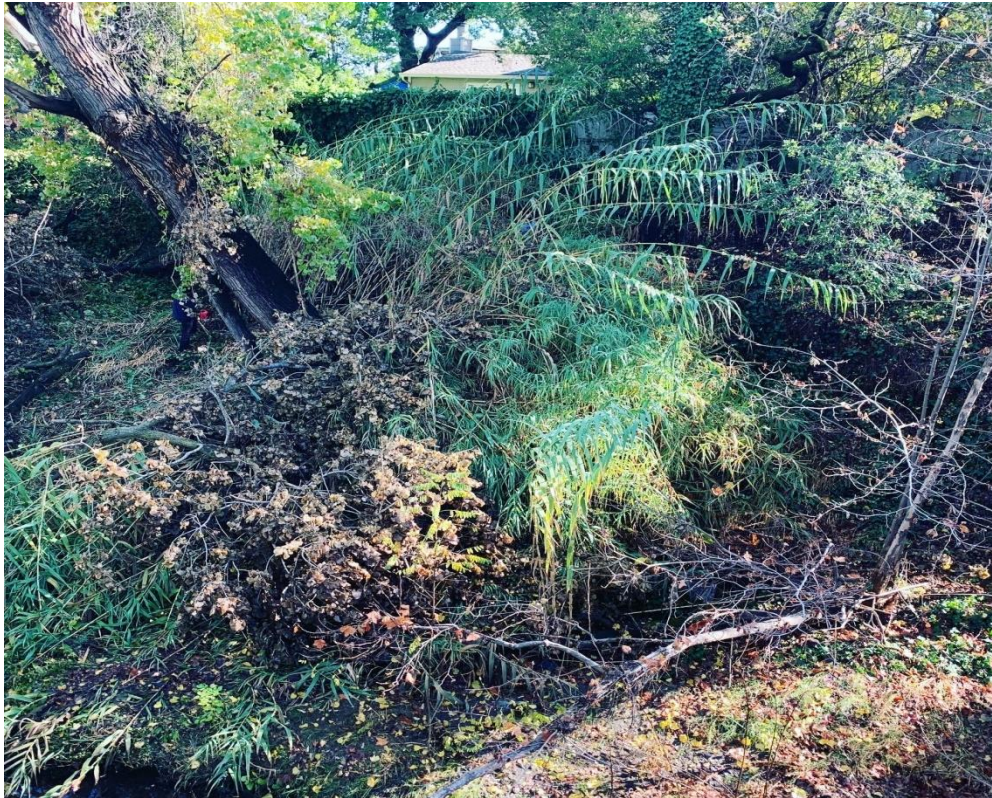
The site was dominated by two Arundo stands, one about 30 ft. by 30 ft. (View 4) and another about 15 ft. by 20 ft. The site was also carpeted with English ivy over a good amount of downed wood, making for treacherous footing. Numerous black locust (*Robinia*

View 4. Walnut Creek site in December 2019. Note the large stand of Arundo at the center of the site and large amounts of downed wood. Note the mature cottonwood tree leaning toward the top left corner of the photo.

We began site clearance in early December 2019. Accessing the site was very difficult, but we created a series of steps down the slope to make access easier. A 60 cu. yd. dumpster was filled with Arundo, ivy, and other invasives. The cut Arundo was then sprayed in late December with Roundup at the manufacturer's rates (3%). View 5 shows the cleared site.

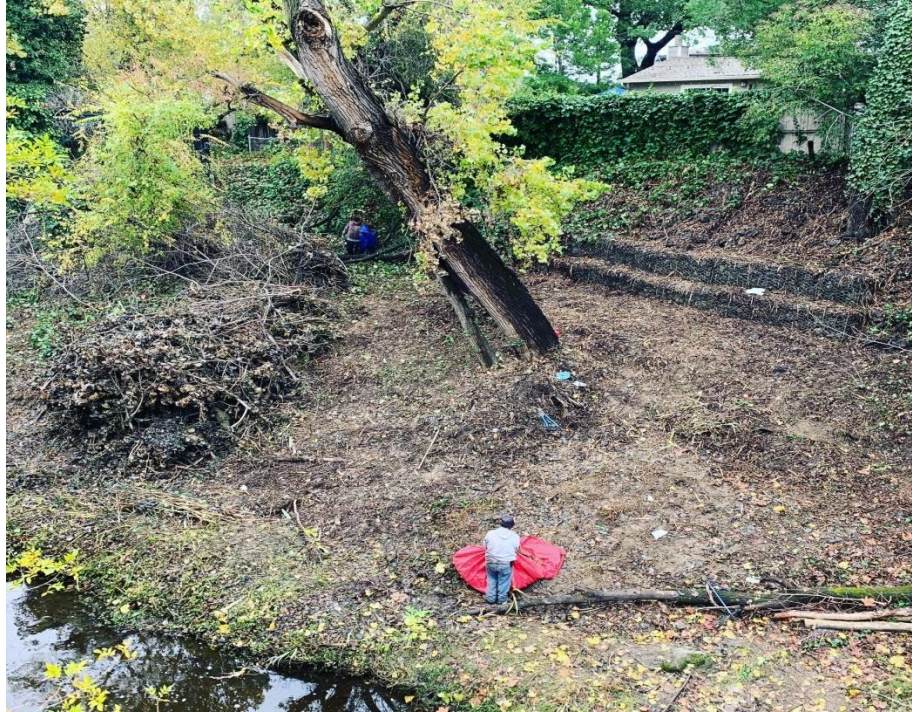
View 5. Walnut Creek site after clearance. The leaning cottonwood tree in the center provides a reference point to compare the cleared site with the pre-cleared site shown in View 4.

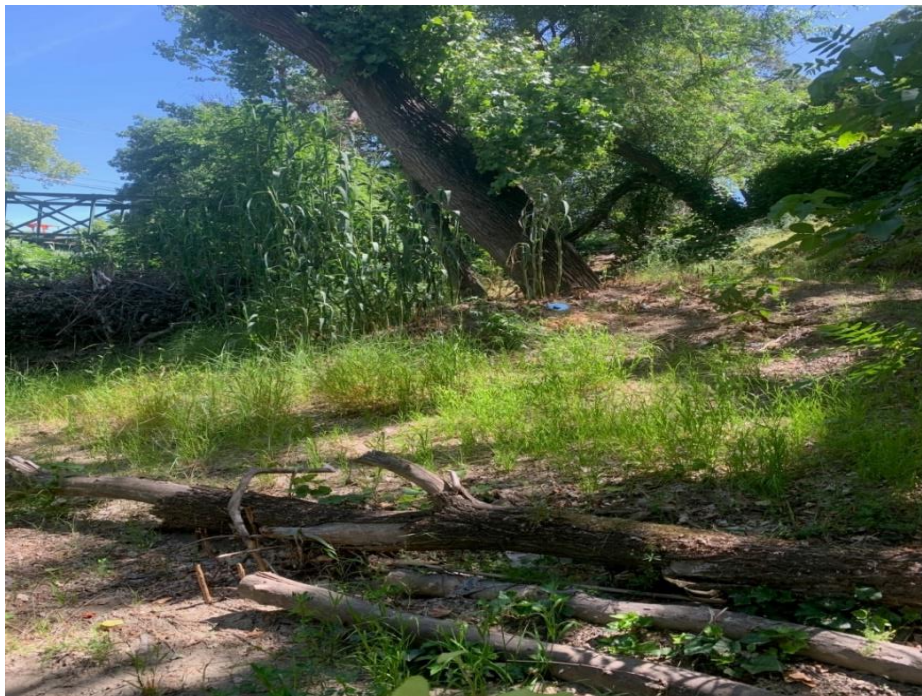
View 6. Walnut Creek site in May 2020. The grass in the center of this photo is creeping wild rye. Note the leaning cottonwood tree that appears in previous Views. Arundo can be seen resprouting to the left of the tree.

Absolute plant cover at this site is relatively low due to the extent of sandy soils, which tend to be problematic for seedlings due to drought stress. That said, native cover is relatively high, as the planted perennials favor sandy soils. Additionally, several natives including mugwort (*Artemisia douglasiana*) are appearing and colonizing patches at the site. The cover by exotics is relatively low compared to the other sites, largely due to the sandy soils and low water retention noted above. Similarly, cover by invasives is low and declining as follow-up control of *Arundo* proceeds.

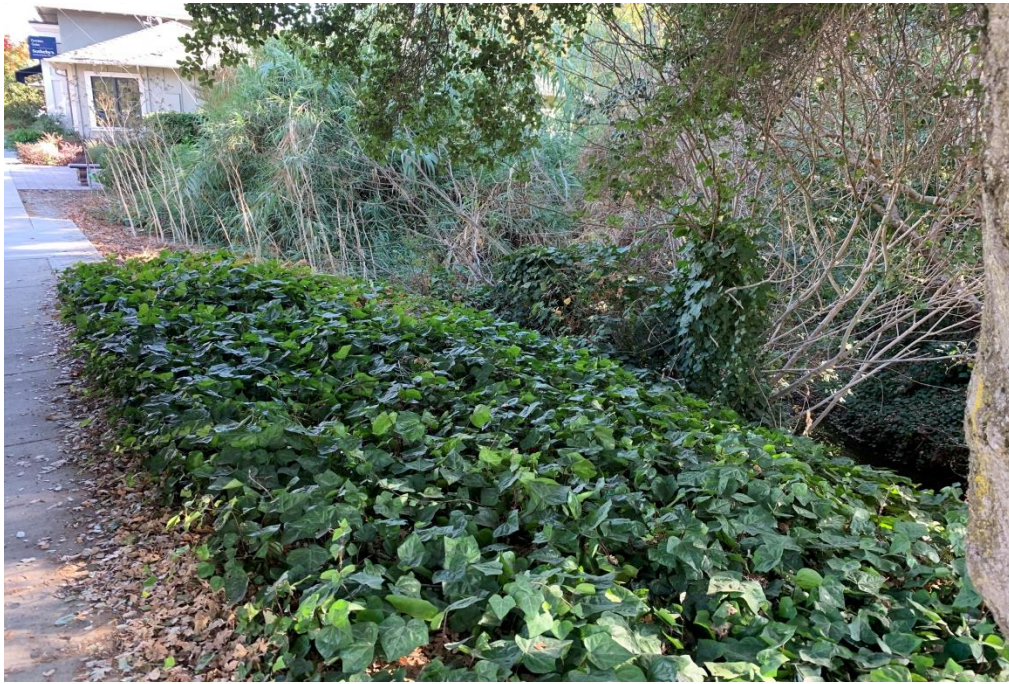
View 7. Lafayette Creek site in December 2019. Note the large stand of Arundo in the background, screening the neighboring building. English ivy covers remainder of site.

We began site clearance in early December. Site accessibility was very good, but the density of the Arundo stand was impressive and unforeseen. Clearing the site required filling three 20 cu. yd. dumpsters, primarily with Arundo stalks over several days (View 8). The site was then sprayed in late December with Roundup at the manufacturer's rates (3%).

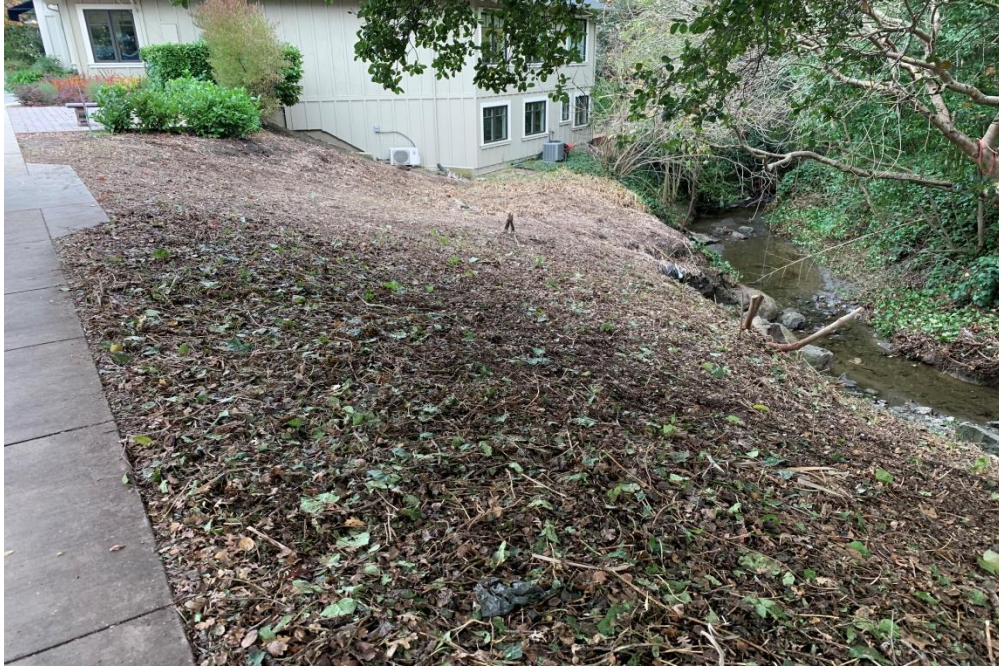
View 8. Lafayette Creek site after clearance. This photo has the same orientation as View 7.

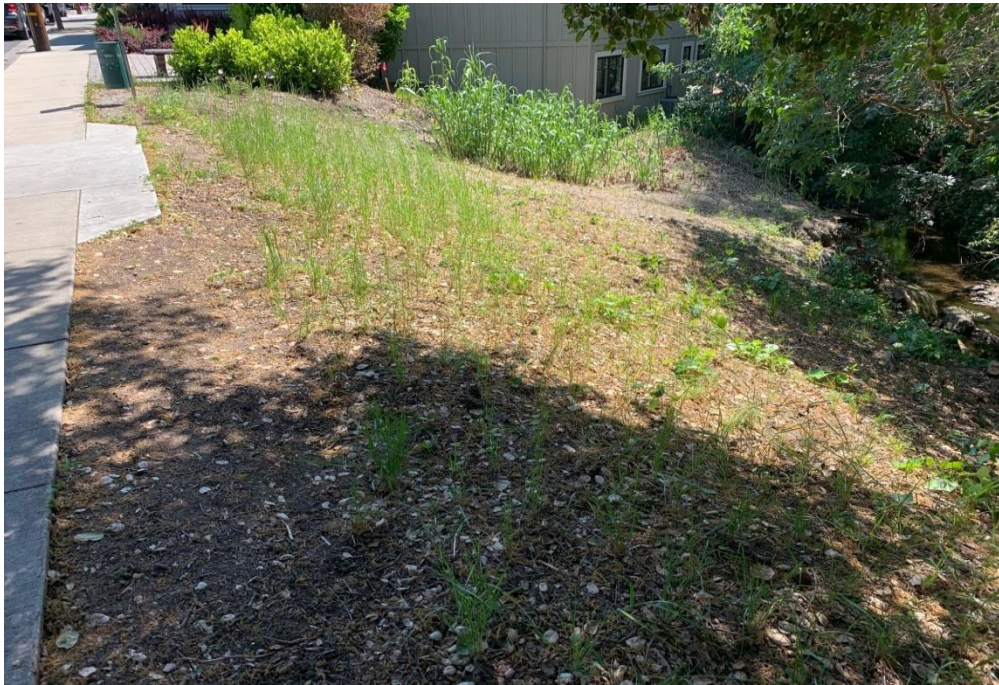
View 9. Lafayette Creek site in May 2020. Grass along upper half of the site is creeping wild rye. Arundo can be seen resprouting at the center of the photo's background. This photo has the same orientation as Views 7 and 8.

Absolute plant cover at the Lafayette Creek site is moderate and reflects the recent plantings and weed control efforts. Native cover is high; the creeping wild rye in particular is growing rapidly at this site. The cover by exotics is relatively low compared to the other sites, probably due to the lack of a seed bank and the slightly shady conditions. Cover by invasives is low and declining as follow-up control of the Arundo proceeds.

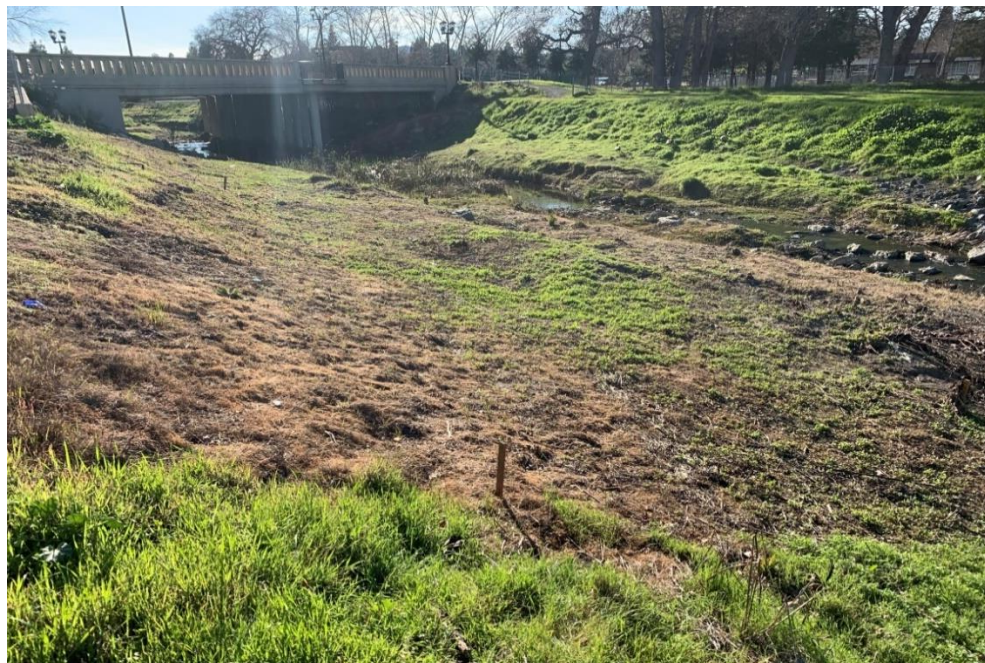
View 10. Grayson Creek site in February 2020 north of the GCR bridge. This photo shows Quad 1 (foreground) and Quad 2 (background), which were sprayed with different herbicides (Roundup in Quad 1 and Weed Slayer in Quad 2). The herbicides used on both Quads controlled nearly 100% of weeds present at that time.

As with the other sites, we began site clearance in December; on this site, though, mowing was the only clearance method used. Herbicide spraying of either Roundup or Weed Slayer was completed on Quads 1 and 2 shortly thereafter as described above (View 10). Planting took place in January 2020 with a large complement of volunteers. We described the spray/no-spray conditions for the four quadrants, and the volunteers eagerly attacked the Quad 3 weeds (View 11).

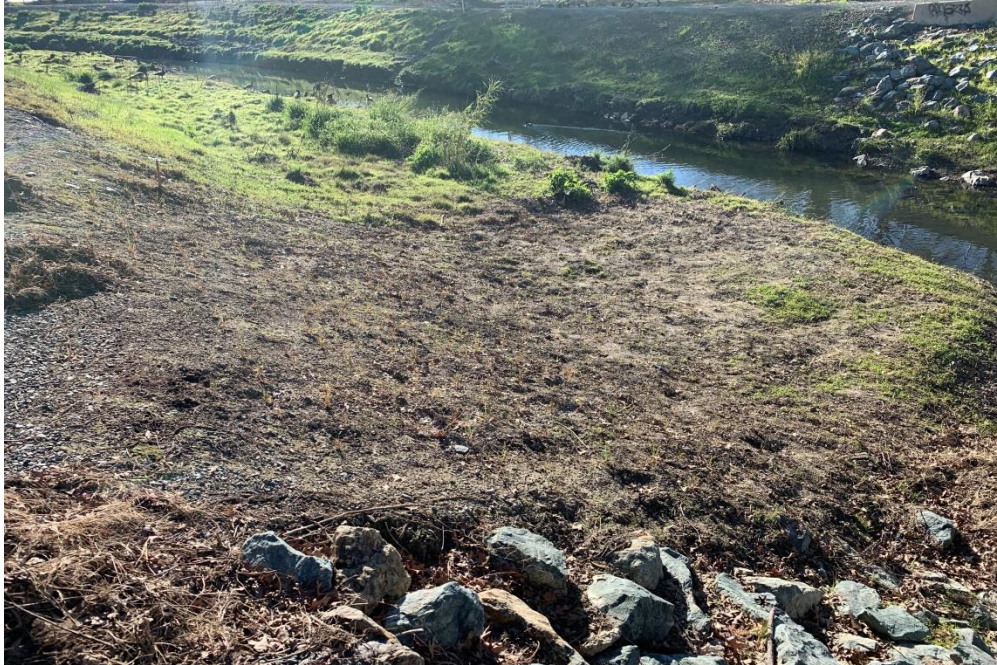
View 11. Grayson Creek site in February 2020 south of the GCR bridge. This photo shows Quad 3 (foreground), which was weeded by volunteers who did an extremely effective job. Quad 4 (background) was not weeded or sprayed.

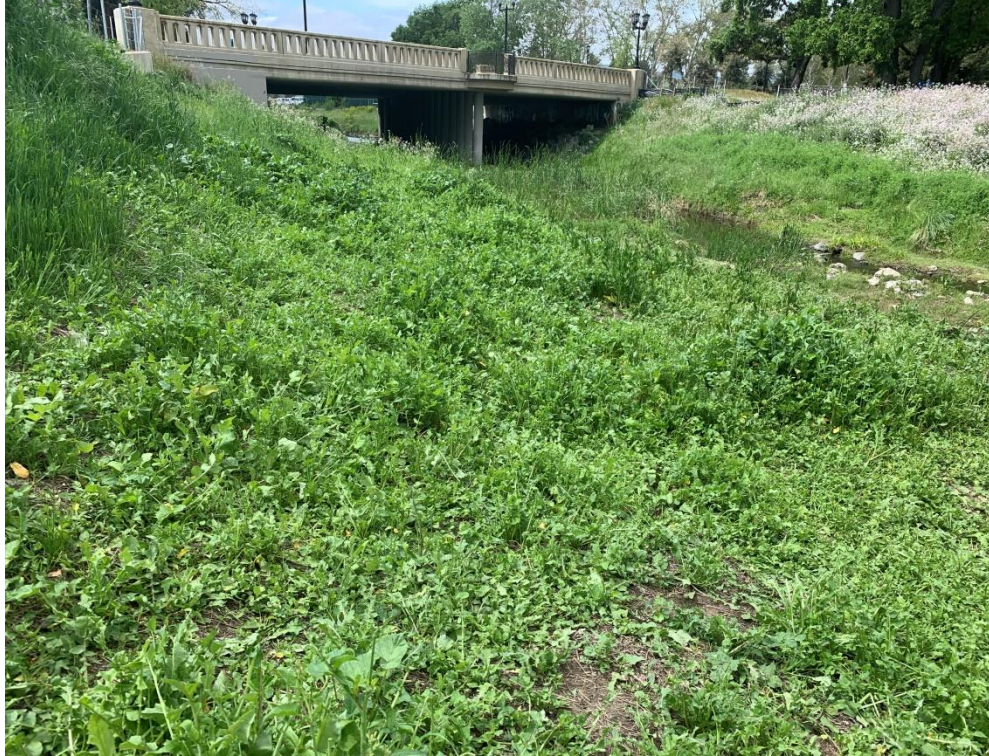
The northern Quads (Quads 1 and 2) at the Grayson Creek site experienced significant weed growth after planting (View 12).

Additionally, a local Canadian goose flock began intensive grazing on all four Quads. The creeping wild rye on the slope was generally spared, but the valley sedge on the terrace was decimated.

View 12. The northern Quads at the Grayson Creek site in May 2020 (same orientation as View 10). Note the dominance of mustard and other weeds.

Absolute plant cover after the restoration effort varies significantly by quadrant. The weed growth and goose grazing reduced native plant cover significantly. However, this site provided some valuable lessons. First, we learned that on open sunny sites, we should expect significant weed growth after site clearance (and soil disturbance) and plan accordingly.
