Walnut Creek Watershed Creek Restoration Program

2021 Monitoring Report

CDFW File #: 1#: #1600-2018-0287-R3

Date Issued: February 2022

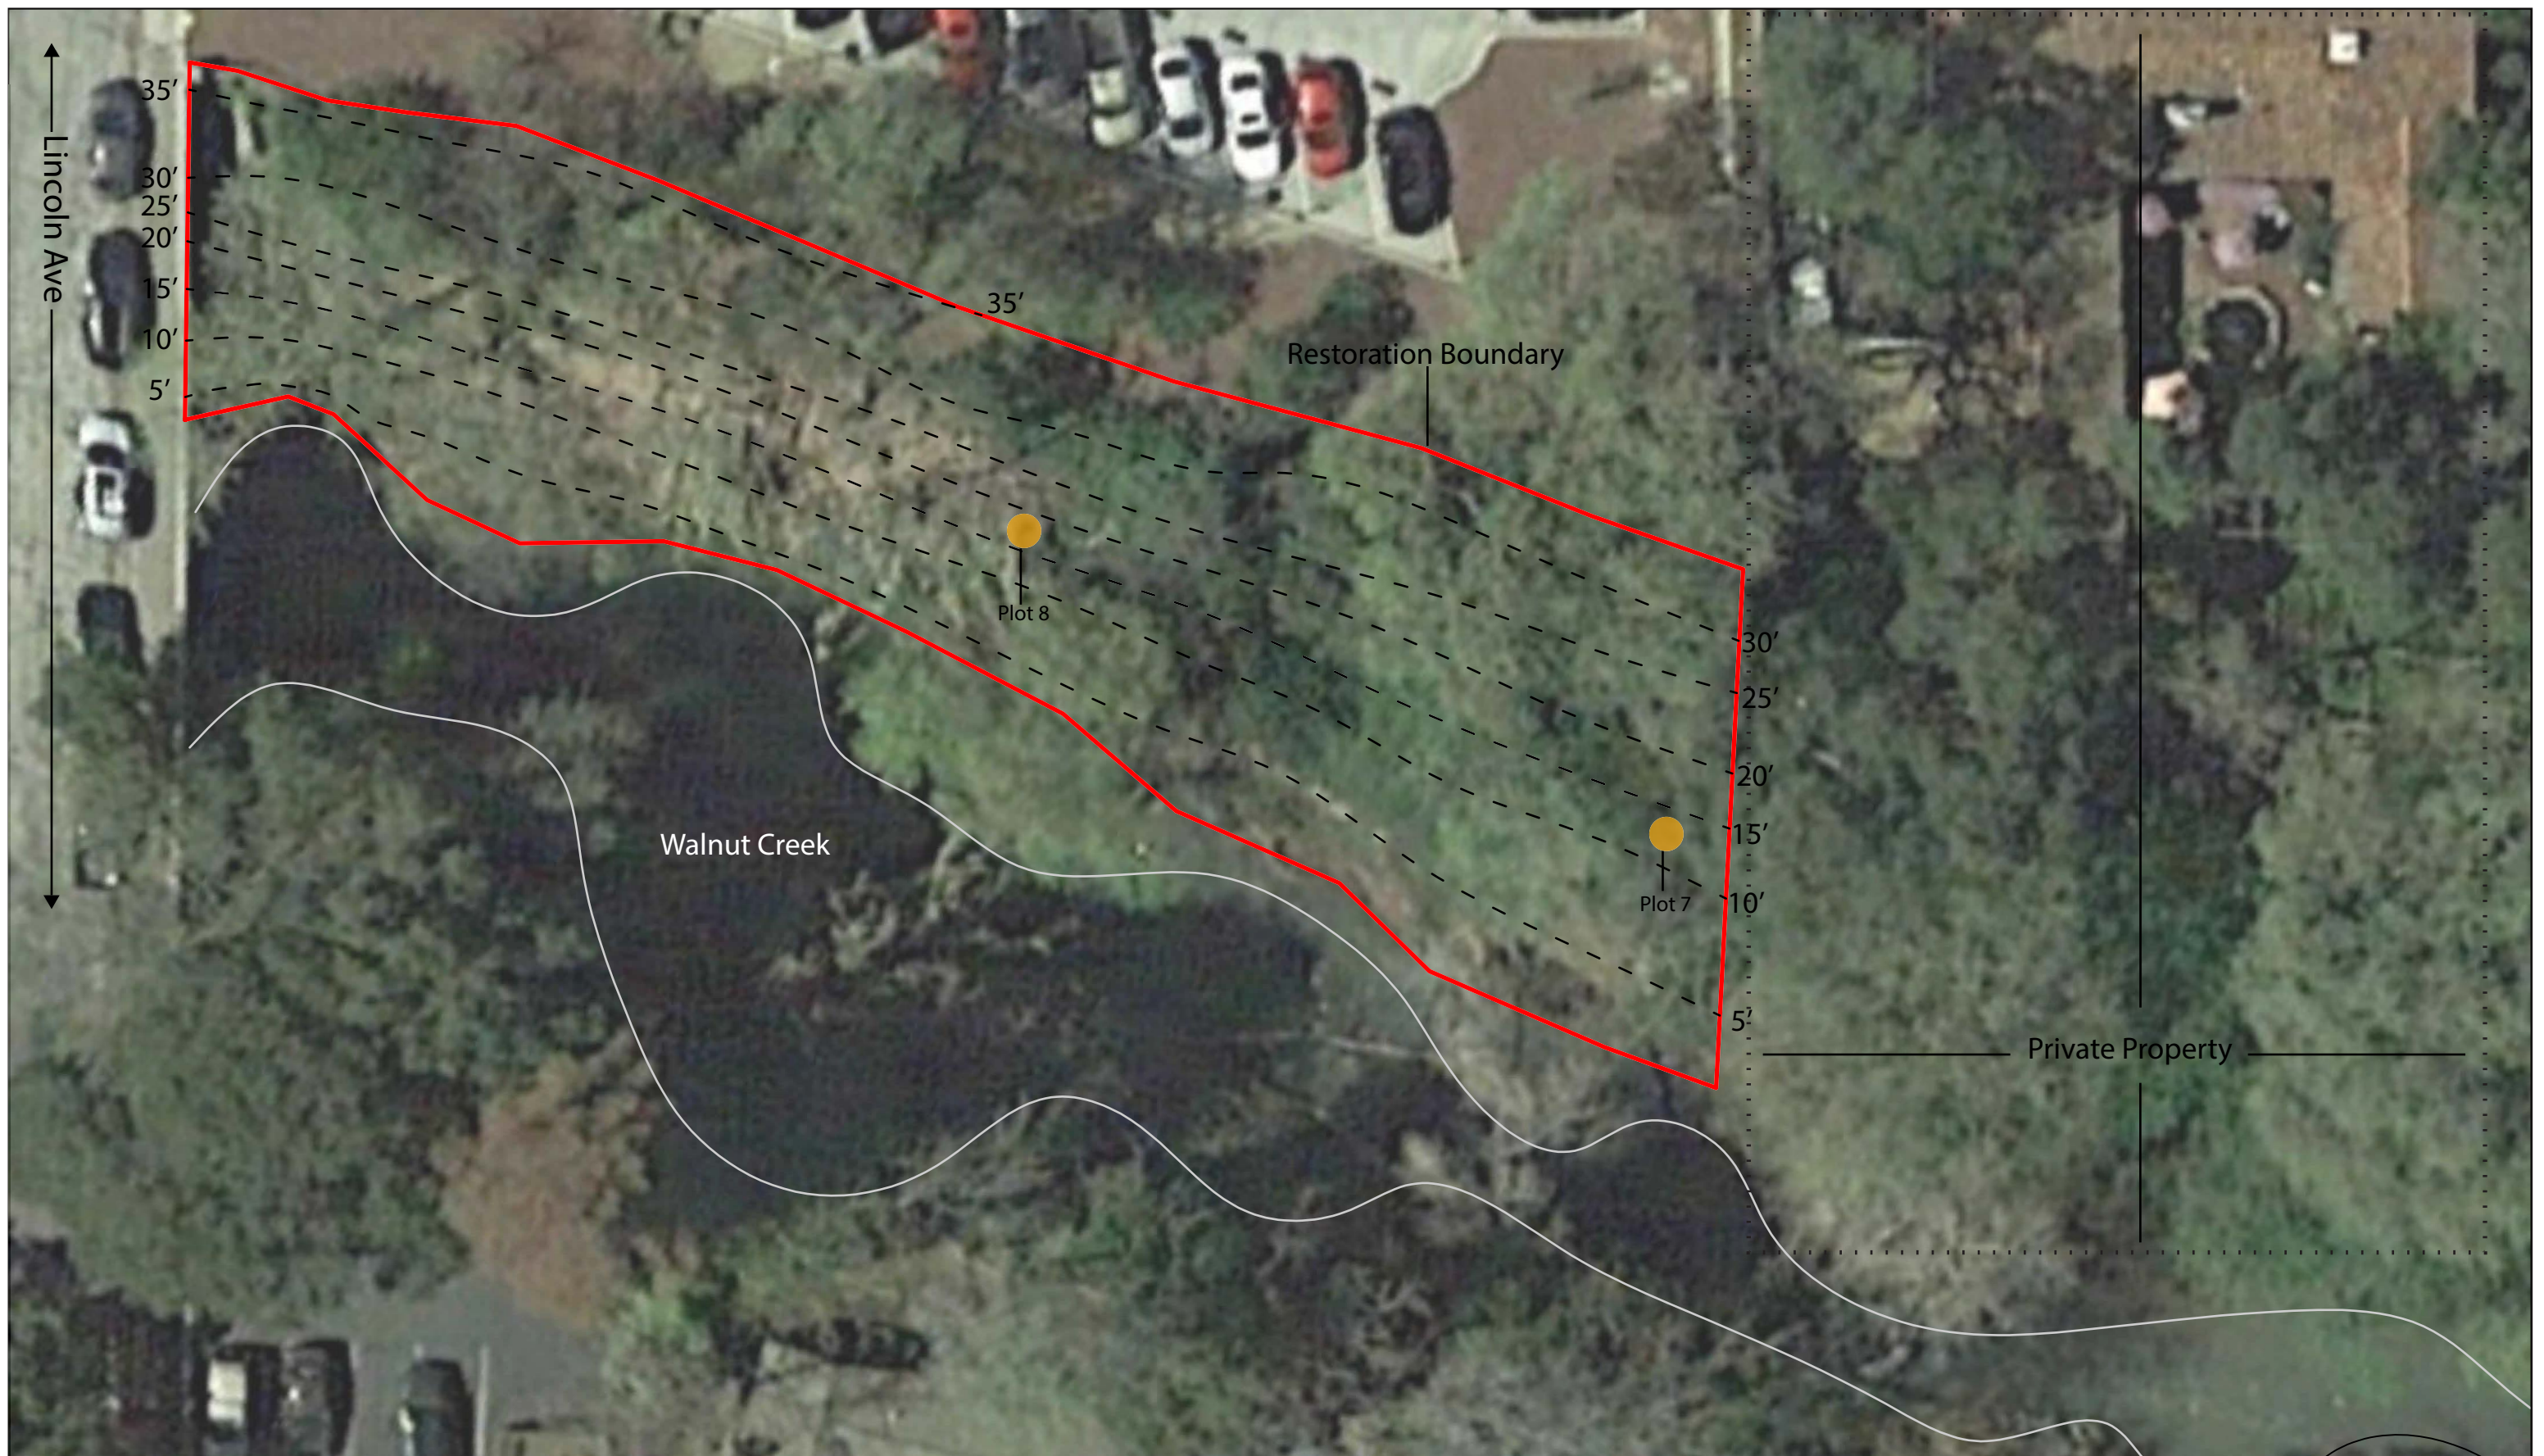
Within the study area, the project site consists of about 10,200 sq. ft. bounded on the west by Lincoln Avenue, on the north by the Walnut Creek Library parking lot, on the east by the private inholding noted above, and on the south by the water's edge of the creek (**Figure 2**). This project site is just downstream of the former Maria Maria site at which the Council and Trust removed a large stand of *Arundo* and restored about 8,000 sq. ft. of bank to native riparian habitat.

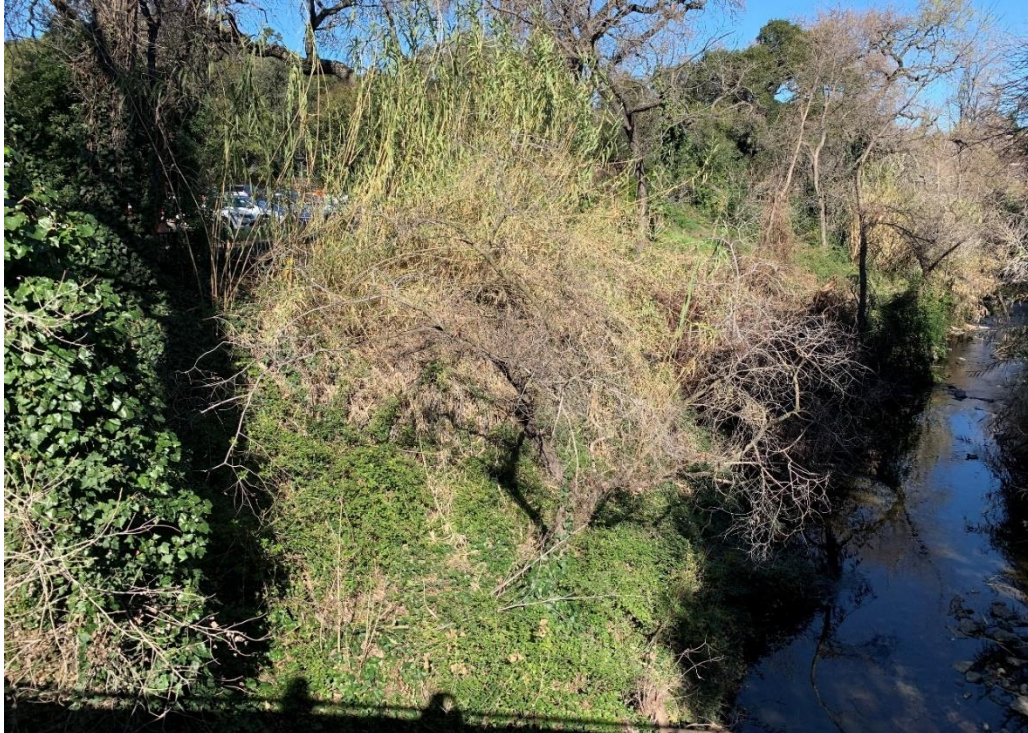
Vegetation in the study area consisted of two distinct components (Table 1 and View 1). The vegetation on the banks was primarily a mix of exotics, many of which are invasive (Table 1). Typical dominants include English ivy (*Hedera helix*), common periwinkle (*Catharanthus roseus*), and Himalayan blackberry (*Rubus armeniacus*), with scattered dense patches of *Arundo*.

View 1: Walnut Creek site prior to restoration from Lincoln Avenue, looking north. February 2020. Note large stand of *Arundo* on west (left) bank.

In September 2020, a Trust contractor cleared the invasive and non-native vegetation from the site and the *Arundo* and other stumps were sprayed with herbicide. A follow-up herbicide spray was then completed in October. Planting of the graminoid plugs (creeping wild rye, valley sedge, etc.) was completed in January 2021. Shortly after planting, the contractor sprayed the planting sites with a pre-emergent herbicide to control annual weeds. Unfortunately, the herbicide chosen also killed 60 to 70% of the newly planted plugs. The contractor reviewed the site with the Trust, recognized their responsibility for the loss of plantings and paid for additional plantings to be done this year.

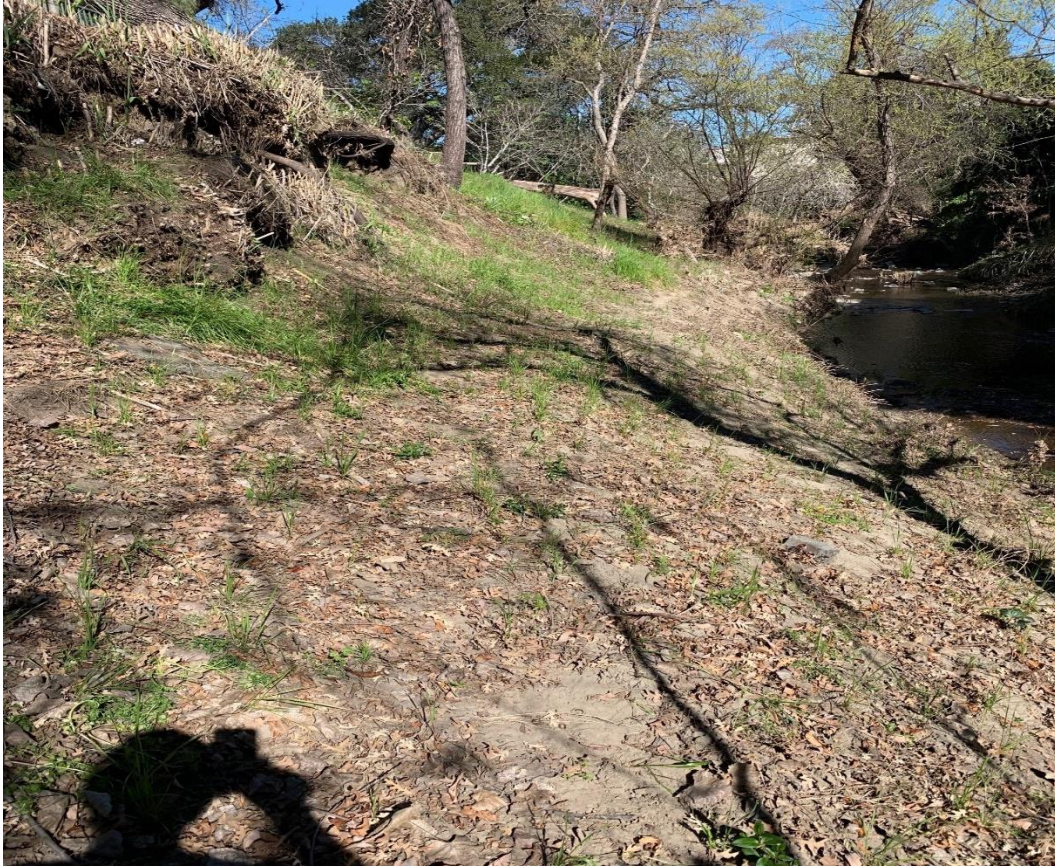
View 2 shows the site in February 2022, after replanting in December 2021.

Absolute plant cover at this site was relatively low at the time of monitoring due to the loss of plantings and the very successful weed control; although the pre-emergent herbicide led to the loss of many plugs, it also was very successful at suppressing weed growth. Native cover was low but cover by exotics was also relatively low, especially compared to the baseline, largely due to the weed control work. Cover by invasives is lower than the baseline but recovering due to the lack of volunteer maintenance work on-site, a result largely of the coronavirus.

View 2: Walnut Creek site looking north (note trees in background visible in View 1). February 2022, after re-planting. Green growth visible in photo are native graminoids.

Overall, despite the loss of most of the plantings in 2021, this site now shows a good deal of promise. The native graminoids have been replanted by the Trust and the City has provided an irrigation source for watering. Weed control has been relatively successful and the site appears to be progressing well.

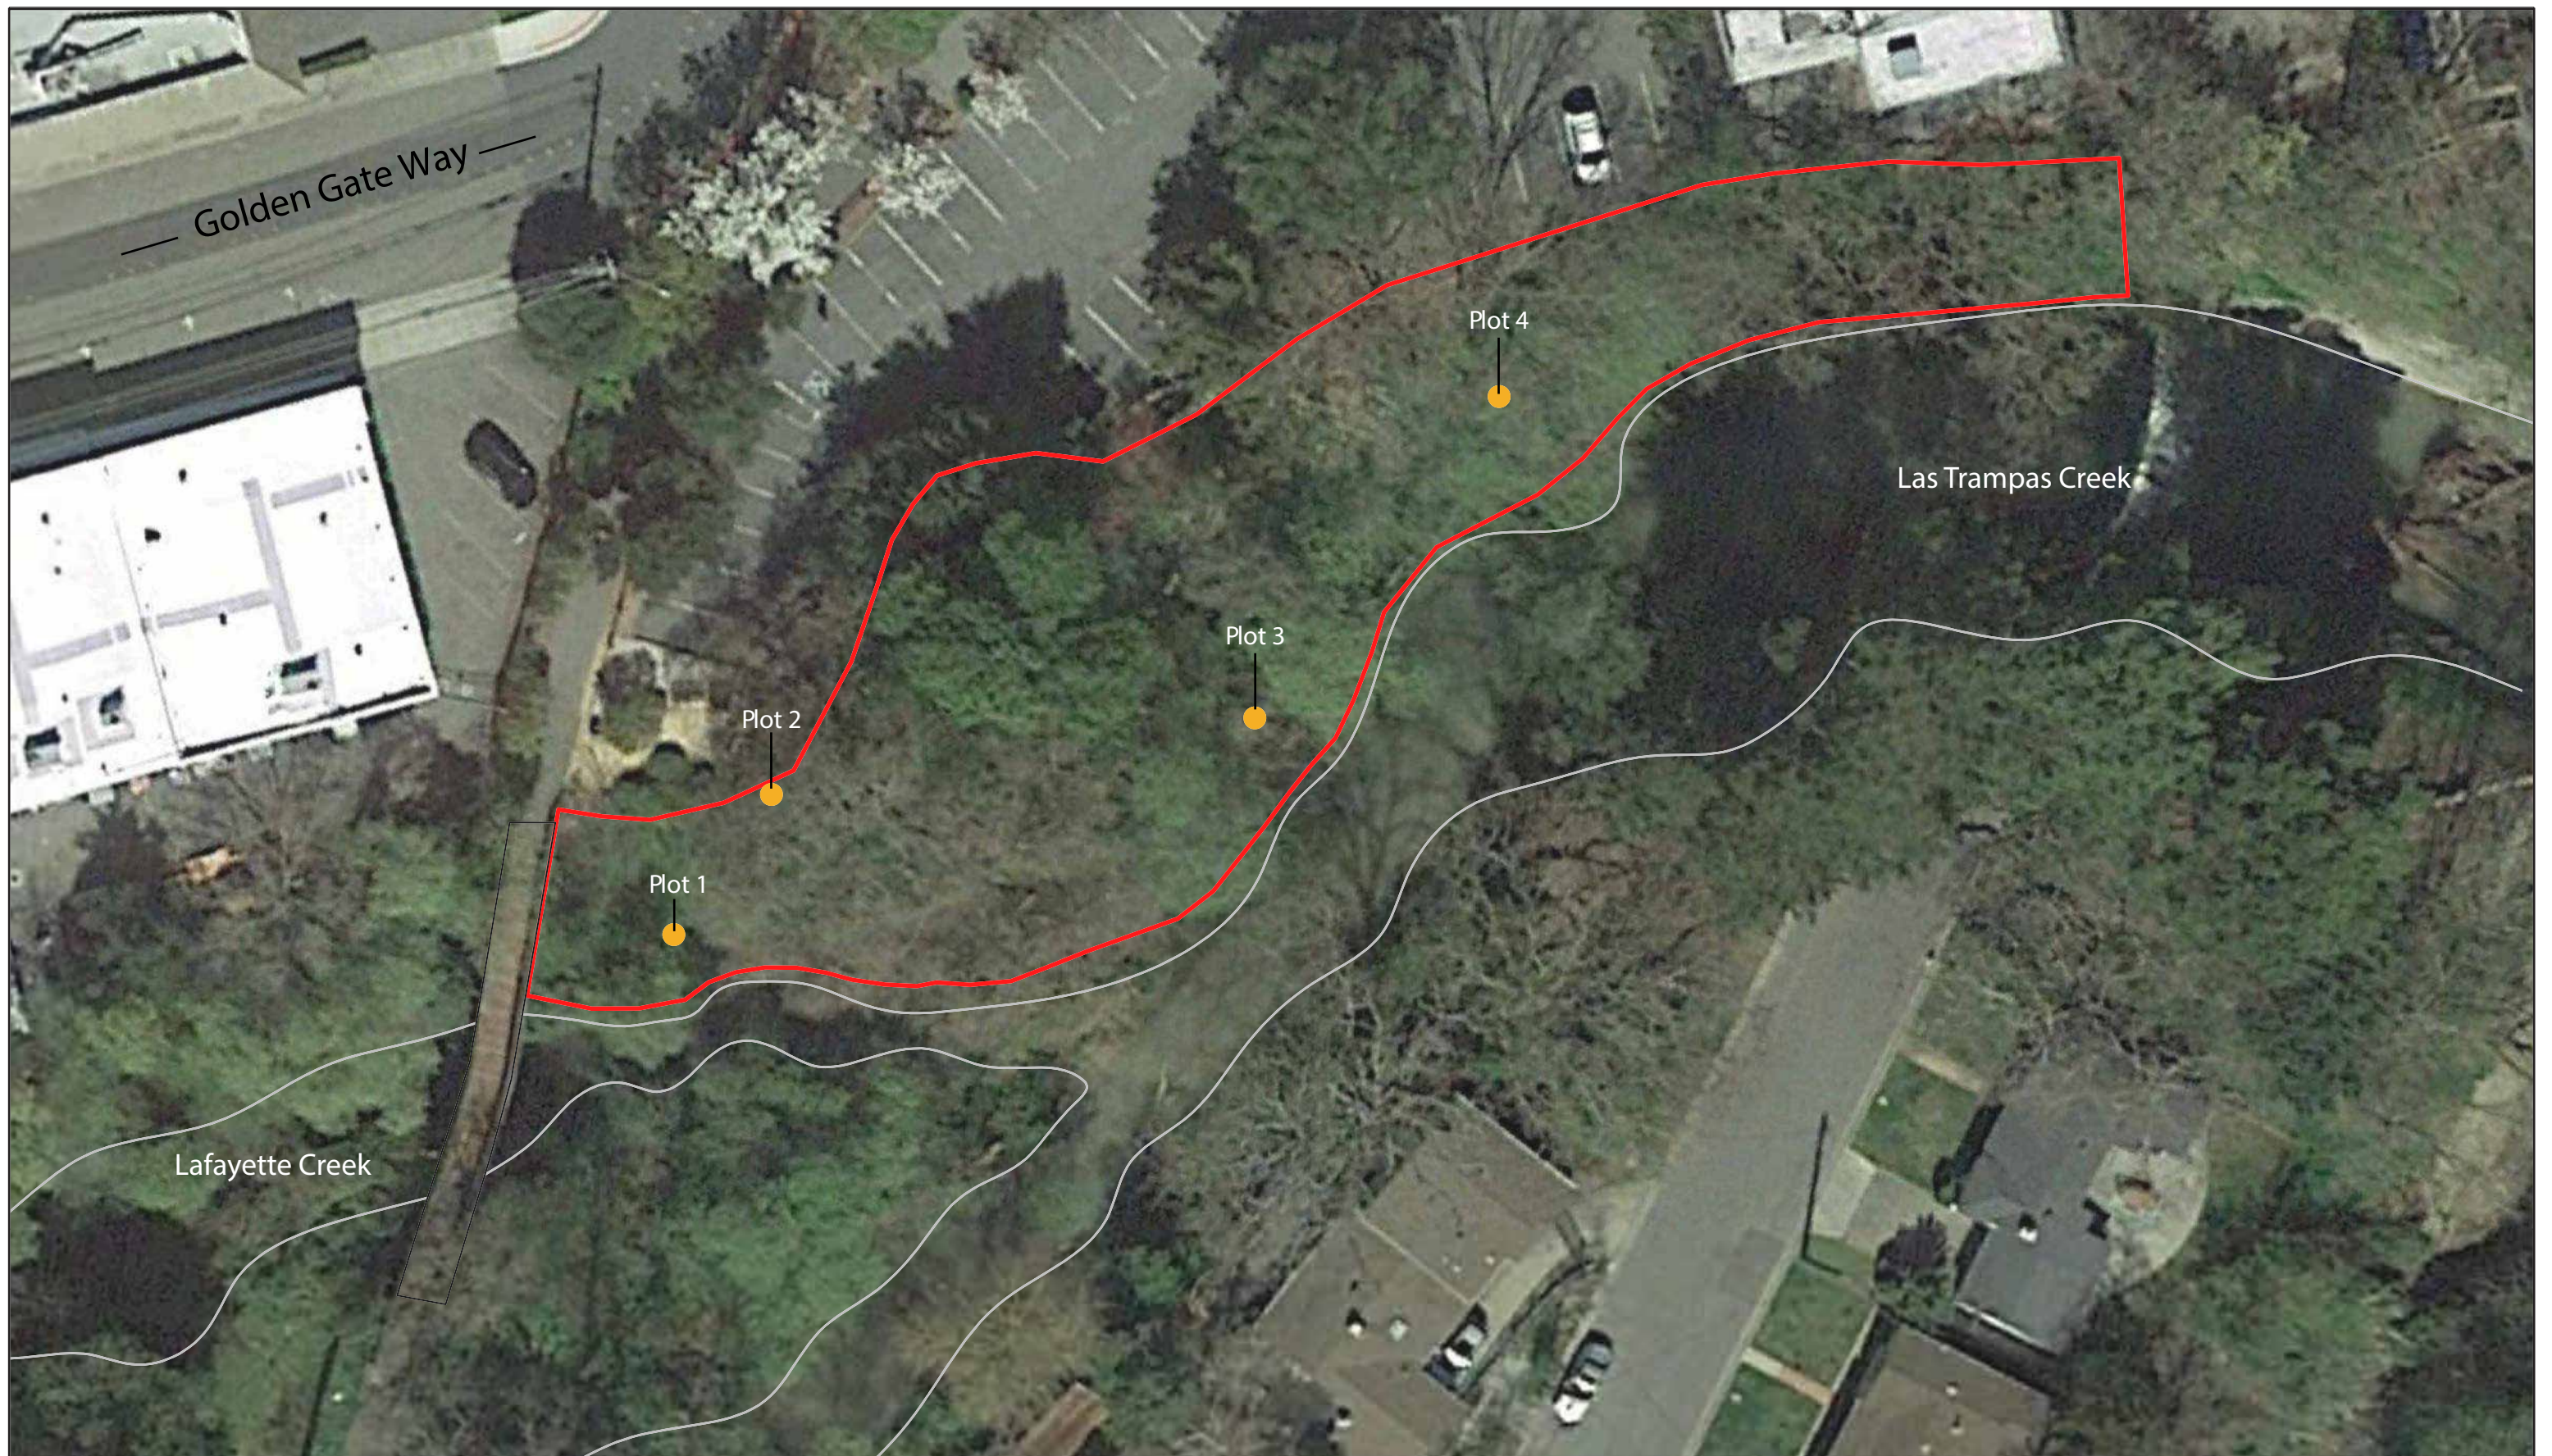
The Lafayette study area for the 2020 restoration effort consisted of the north bank of Lafayette Creek just before its confluence with Las Trampas Creek from the pedestrian bridge over Lafayette Creek downstream to upstream of the “Las Trampas curve” where Las Trampas Creek makes an abrupt right turn (**Figure 3**). This is all public land owned by the City of Lafayette, Contra Costa County Flood Control District (County FCD) and East Bay Regional Park District (EBRPD) in the City of Lafayette. Within the study area, the project site consisted of about 7,300 sq. ft. and is bounded on the west by the pedestrian bridge, on the north by the public/private parking lot, on the south by the water’s edge of the creek, and on the east by an unmarked line (**Figure 4**). This project site is downstream of the Lafayette Phase 1 site at which the Project

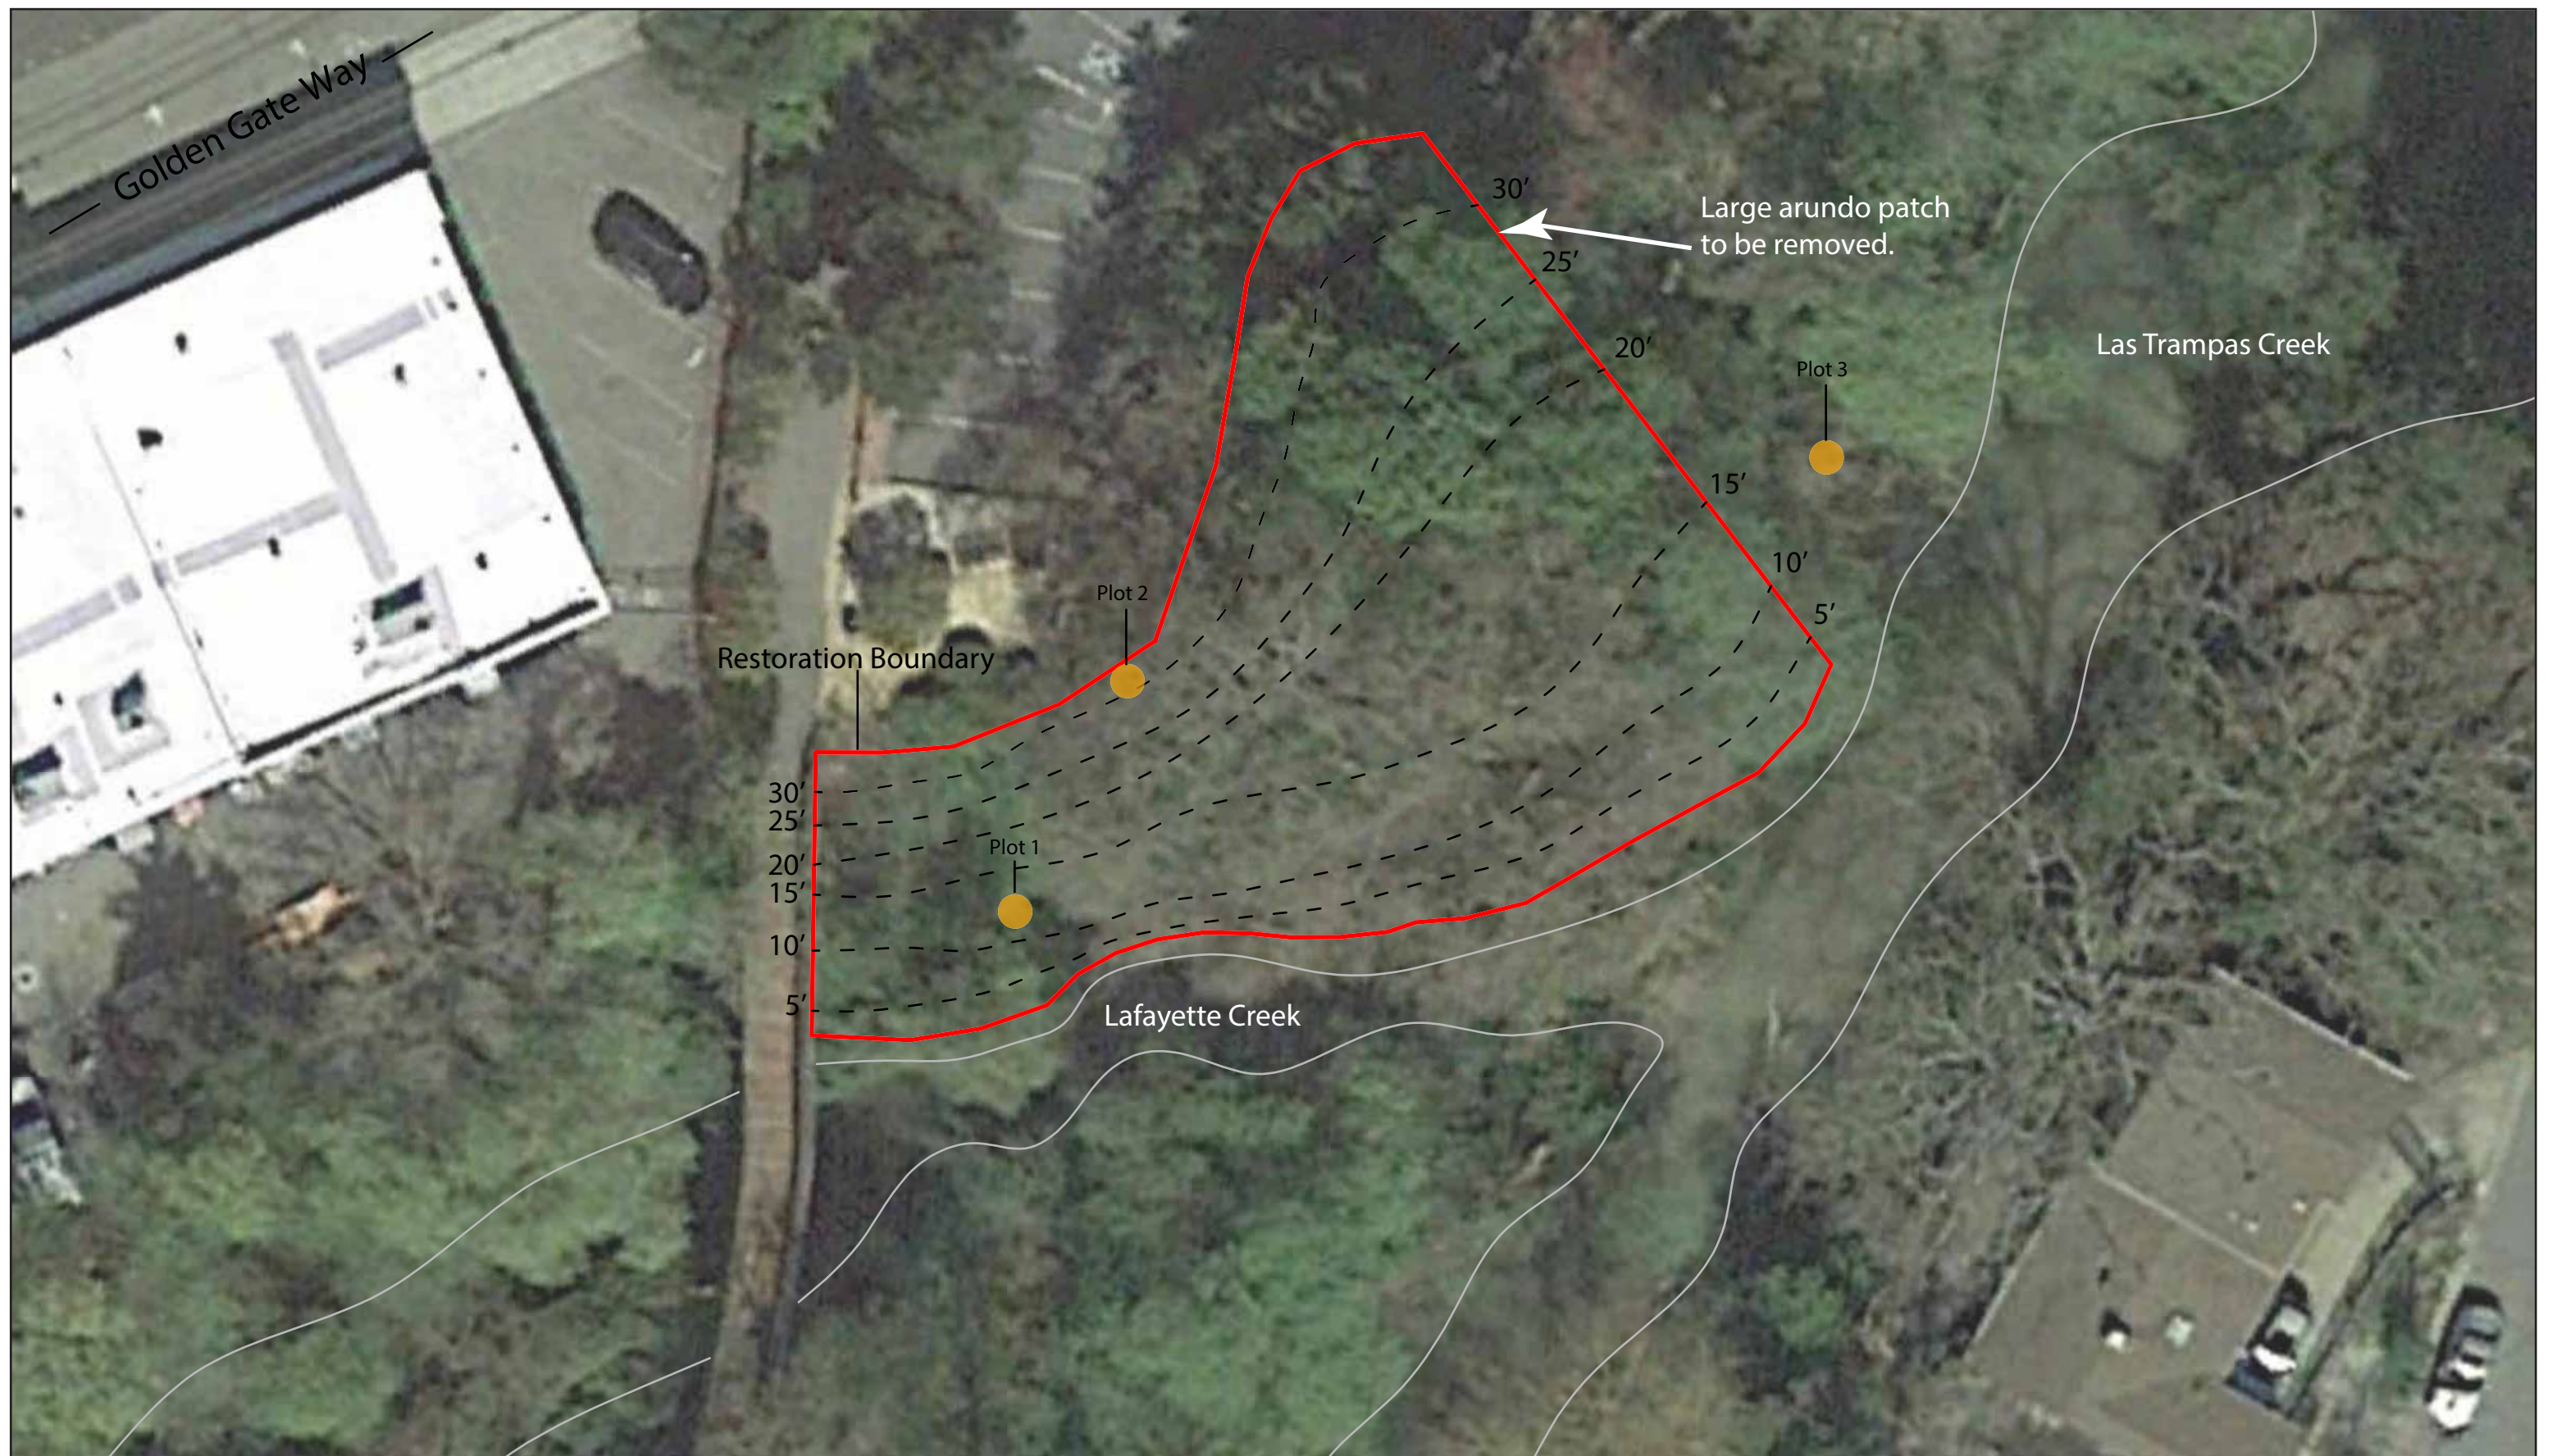
The creek banks in the study area range from moderately steep to moderately gentle. The project site averages about a 3:1 slope with an elevation drop of about 30 ft. over 60-to-120 ft. of width. This was gentle enough to plant, as evidenced by the work done upstream.

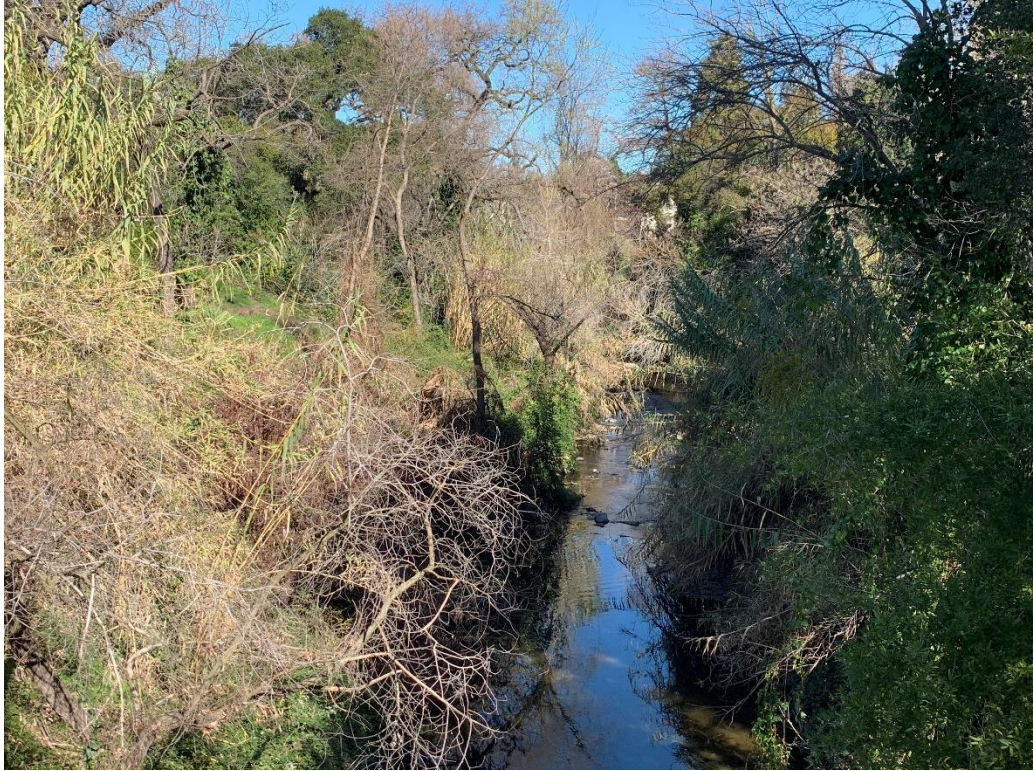
As in the Walnut Creek study area, vegetation in the Lafayette study area consisted of two distinct components (Table 3 and View 3). However, unlike Walnut Creek, the Lafayette Creek slopes were dominated by one invasive species, Elmleaf (thornless) blackberry (*Rubus ulmifolius* var. *anoplothysus*) with an admixture of clumps of *Arundo*. English ivy was also present.

View 3: Lafayette site (left bank), looking north. February 2020. Note large stand of *Arundo* at upper left and lack of native trees in floodplain.

In September 2020, the invasive and non-native vegetation were cleared from the site by a Trust contractor and the *Arundo* and other stumps sprayed with herbicide. A follow-up herbicide spray was then completed in October.

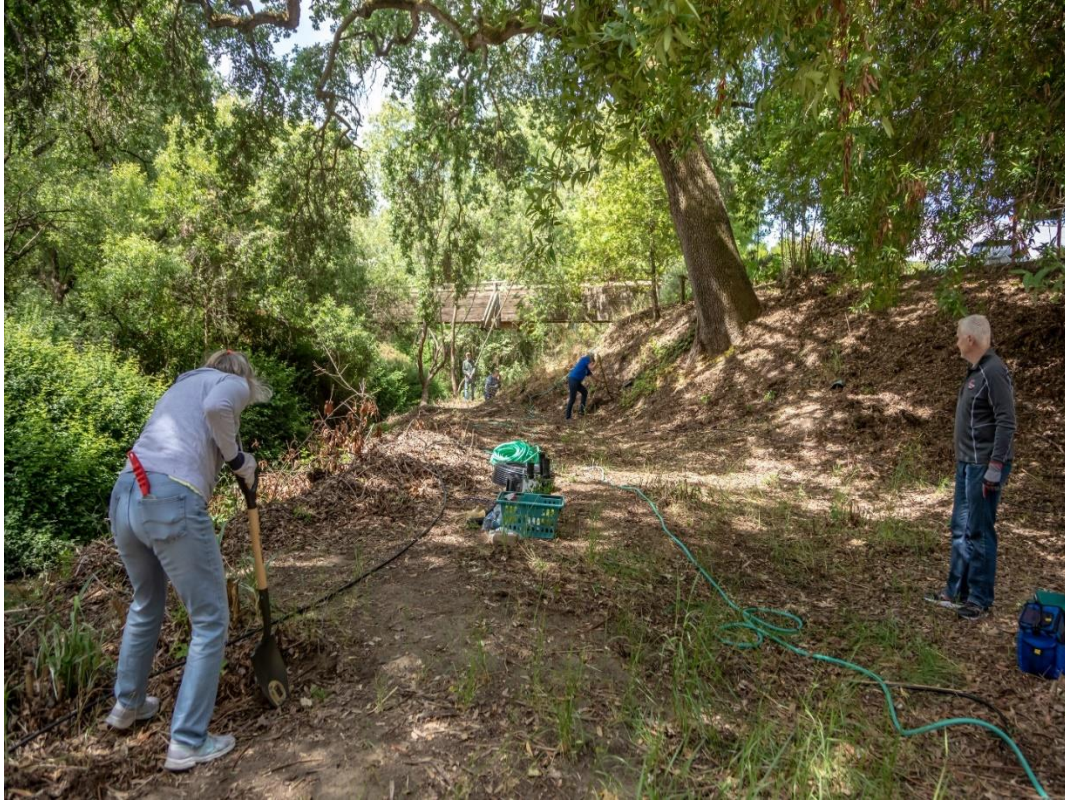
View 4: Lafayette site, April 2020. Volunteer installation of drip irrigation system, trees and shrubs.

Planting of the graminoid plugs (creeping wild rye, valley sedge, etc.) was completed in January 2021. As with the Walnut Creek site, the contractor sprayed the planting sites with a pre-emergent herbicide to control annual weeds, which then killed 60 to 70% of the newly planted plugs. The contractor paid for additional plantings to be done. In April, the community volunteers with the Trust installed a drip irrigation system and planted 16 native trees and shrubs on-site (View 4).

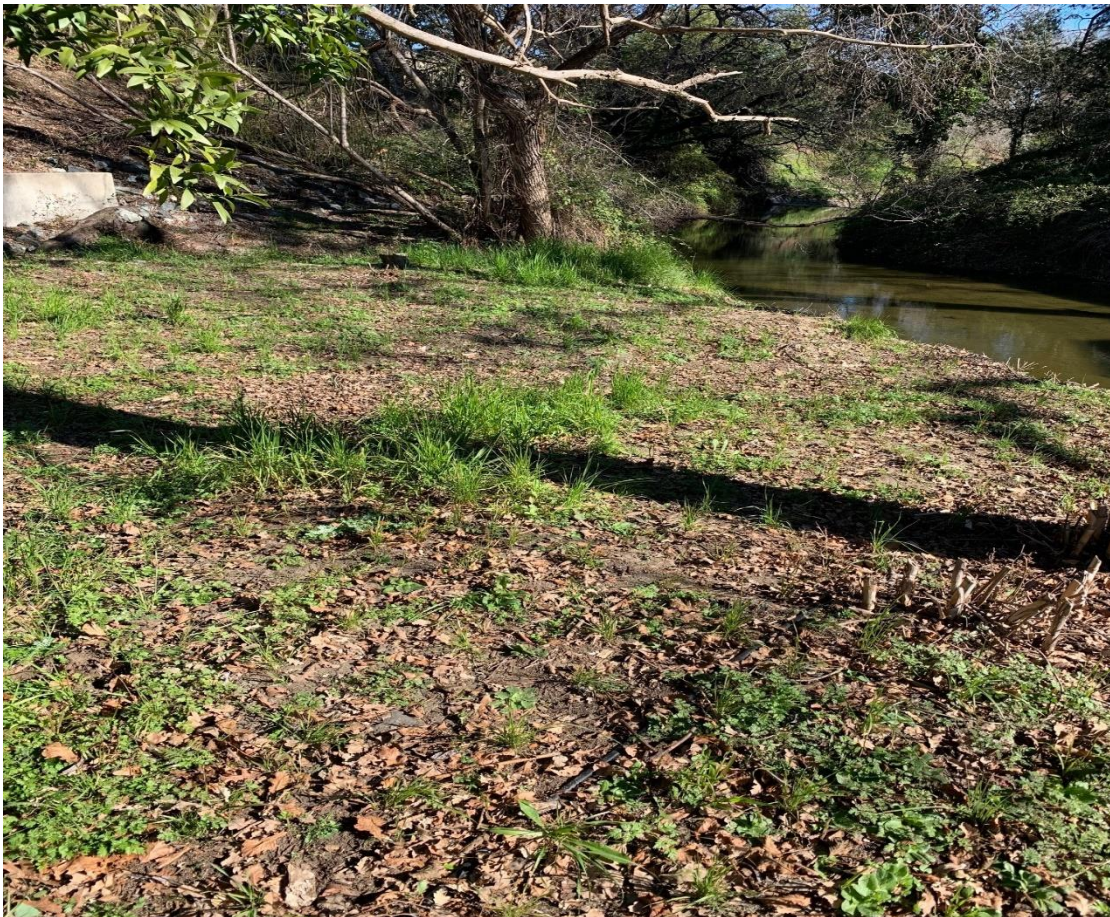
View 5 shows the site in February 2022, after replanting in December 2021.

Like Walnut Creek, absolute plant cover at this site was relatively low due to the loss of plantings and the very successful weed control; although the pre-emergent herbicide led to the loss of many plugs, it also was very successful at suppressing weed growth. Native cover was low but cover by exotics is relatively low compared to the baseline, largely due to the weed control work. Cover by invasives is very low due to the volunteer maintenance work on-site, which has been on-going despite the coronavirus.

View 5: Lafayette site, February 2022, looking north after replanting. Note large tree in background; same tree is visible in View 3.
