# Friends of San Ramon Creek

# 2021 Arundo Removal Efforts

# Report to California Department of Fish and Wildlife

Ref: Notification #1600-2018-0287-R3

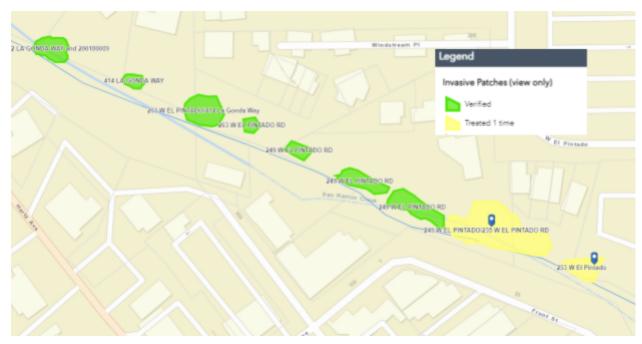
Figure 2. Treated Patches Near Front St, Danville

Across the stream from Front St in Danville was a long, deep and tall patch that was easily visible to anyone on Front St. The Arundo continued for the length of Front Street and beyond all the way to La Gonda Way. In 2021 we approached the property owners at 233, 235 and 249 West El Pintado Rd and received permission to access and remove their Arundo using a volunteer crew.

The Arundo had killed all other plants and most trees where it had been growing. We are hopeful that some of the trees that were taller than the Arundo will survive. There were a great deal of dead Arundo stalks indicating that this patch had been there for ten years or more.

Starting June 15, 2021 a crew of 5 to 10 people worked each Friday morning to remove the Arundo. Over the summer the crew removed and treated approximately 10,000 sf of Arundo. The stalks were hauled up ramps to one of two access points. The Arundo was chipped into dumpsters provided by Republic Services. The stumps were recut within a few hours of the initial cut and immediately treated with a 4% solution of Round-Up custom with Marklt dye.

This infestation continues downstream towards La Gonda. There is at least another 5,000 sf on the 249 West El Pintado Rd property. FSRC expects to continue work on this in 2022.

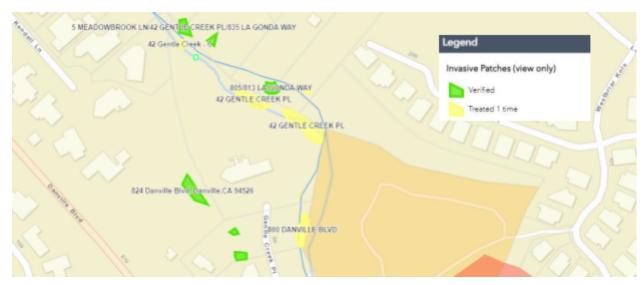
Figure 5. Map Showing Treated Patches Near Gentle Creek Place

Arundo because they had experienced serious erosion on their stream bank that was at least in part caused by the Arundo redirecting the flow of the creek.

Over 9000 sf of Arundo was removed from the 5 patches marked in yellow below. This included the patch that was changing the course of the stream.

FSRC and the 42 Gentle Creek PI homeowner jointly hired a contractor to remove as much Arundo as budget would allow and then the FSRC volunteer crew added extra work days to finish what the contractor could not complete and also removed the Arundo at 800 Danville Blvd.

The Arundo from the 42 Gentle Creek PI property was hauled out, chipped and removed from the site. The Arundo on the 800 Danville property was accessed through the open space behind the Briar Knolls development. The Arundo was chipped onto the edge of the plateau above the creek. All patches were recut and the stumps treated with Roundup Custom with Marklt dye.

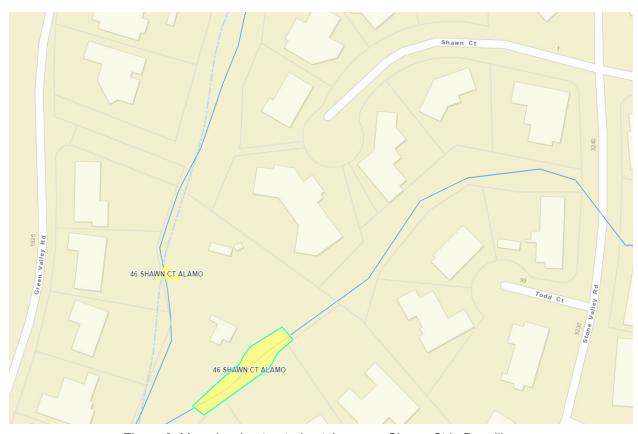
Figure 9. Map showing treated patches near Shawn Ct in Danville.

The Shawn Ct patch was a large (5000 sf) patch, far upstream in the watershed. There are very few other instances of Arundo in this area. It appears to have been planted by a landowner many years ago and has been allowed to expand to this large patch by inattention for many years.

FSRC approached the landowner early in the summer of 2021 to understand what it would take to remove the Arundo. FSRC decided that the best approach would be to use large community groups to work on this patch. A group of Boy Scouts (16 scouts) and two Church groups (23 and 25 people) almost eliminated it. The regular volunteer crew finished it up and cleaned up the debris. The canes were chipped into an open field on the property that was well above the waterline.

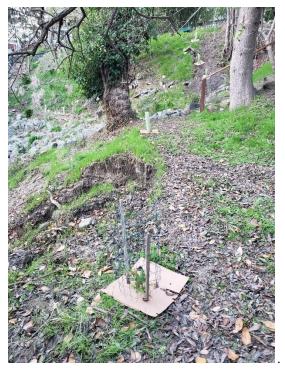
Figure 15. December 4, 2021, 134 El Portal, Danville. Caged and tubed plantings

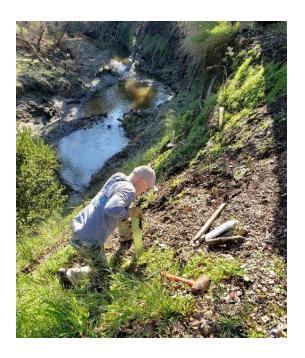
Figure 18. December 18, 2021, 42 Gentle Creek PI, Danville. Planting bushes along a steep bank

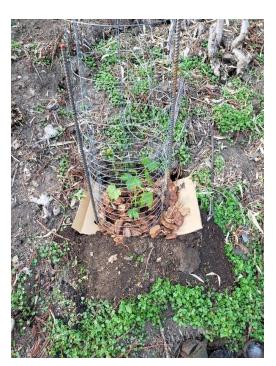
Figure 20. December 4, 2021, 20 Sandra Ct, Alamo. Red-Flowering Currant caged and mulched.
