Arundo Removal and Replacement Team 2019 Monitoring Report

CDFW File #: 1#: #1600-2018-0287-R3

Arundo Removal and Replacement Team

2019 Monitoring Report

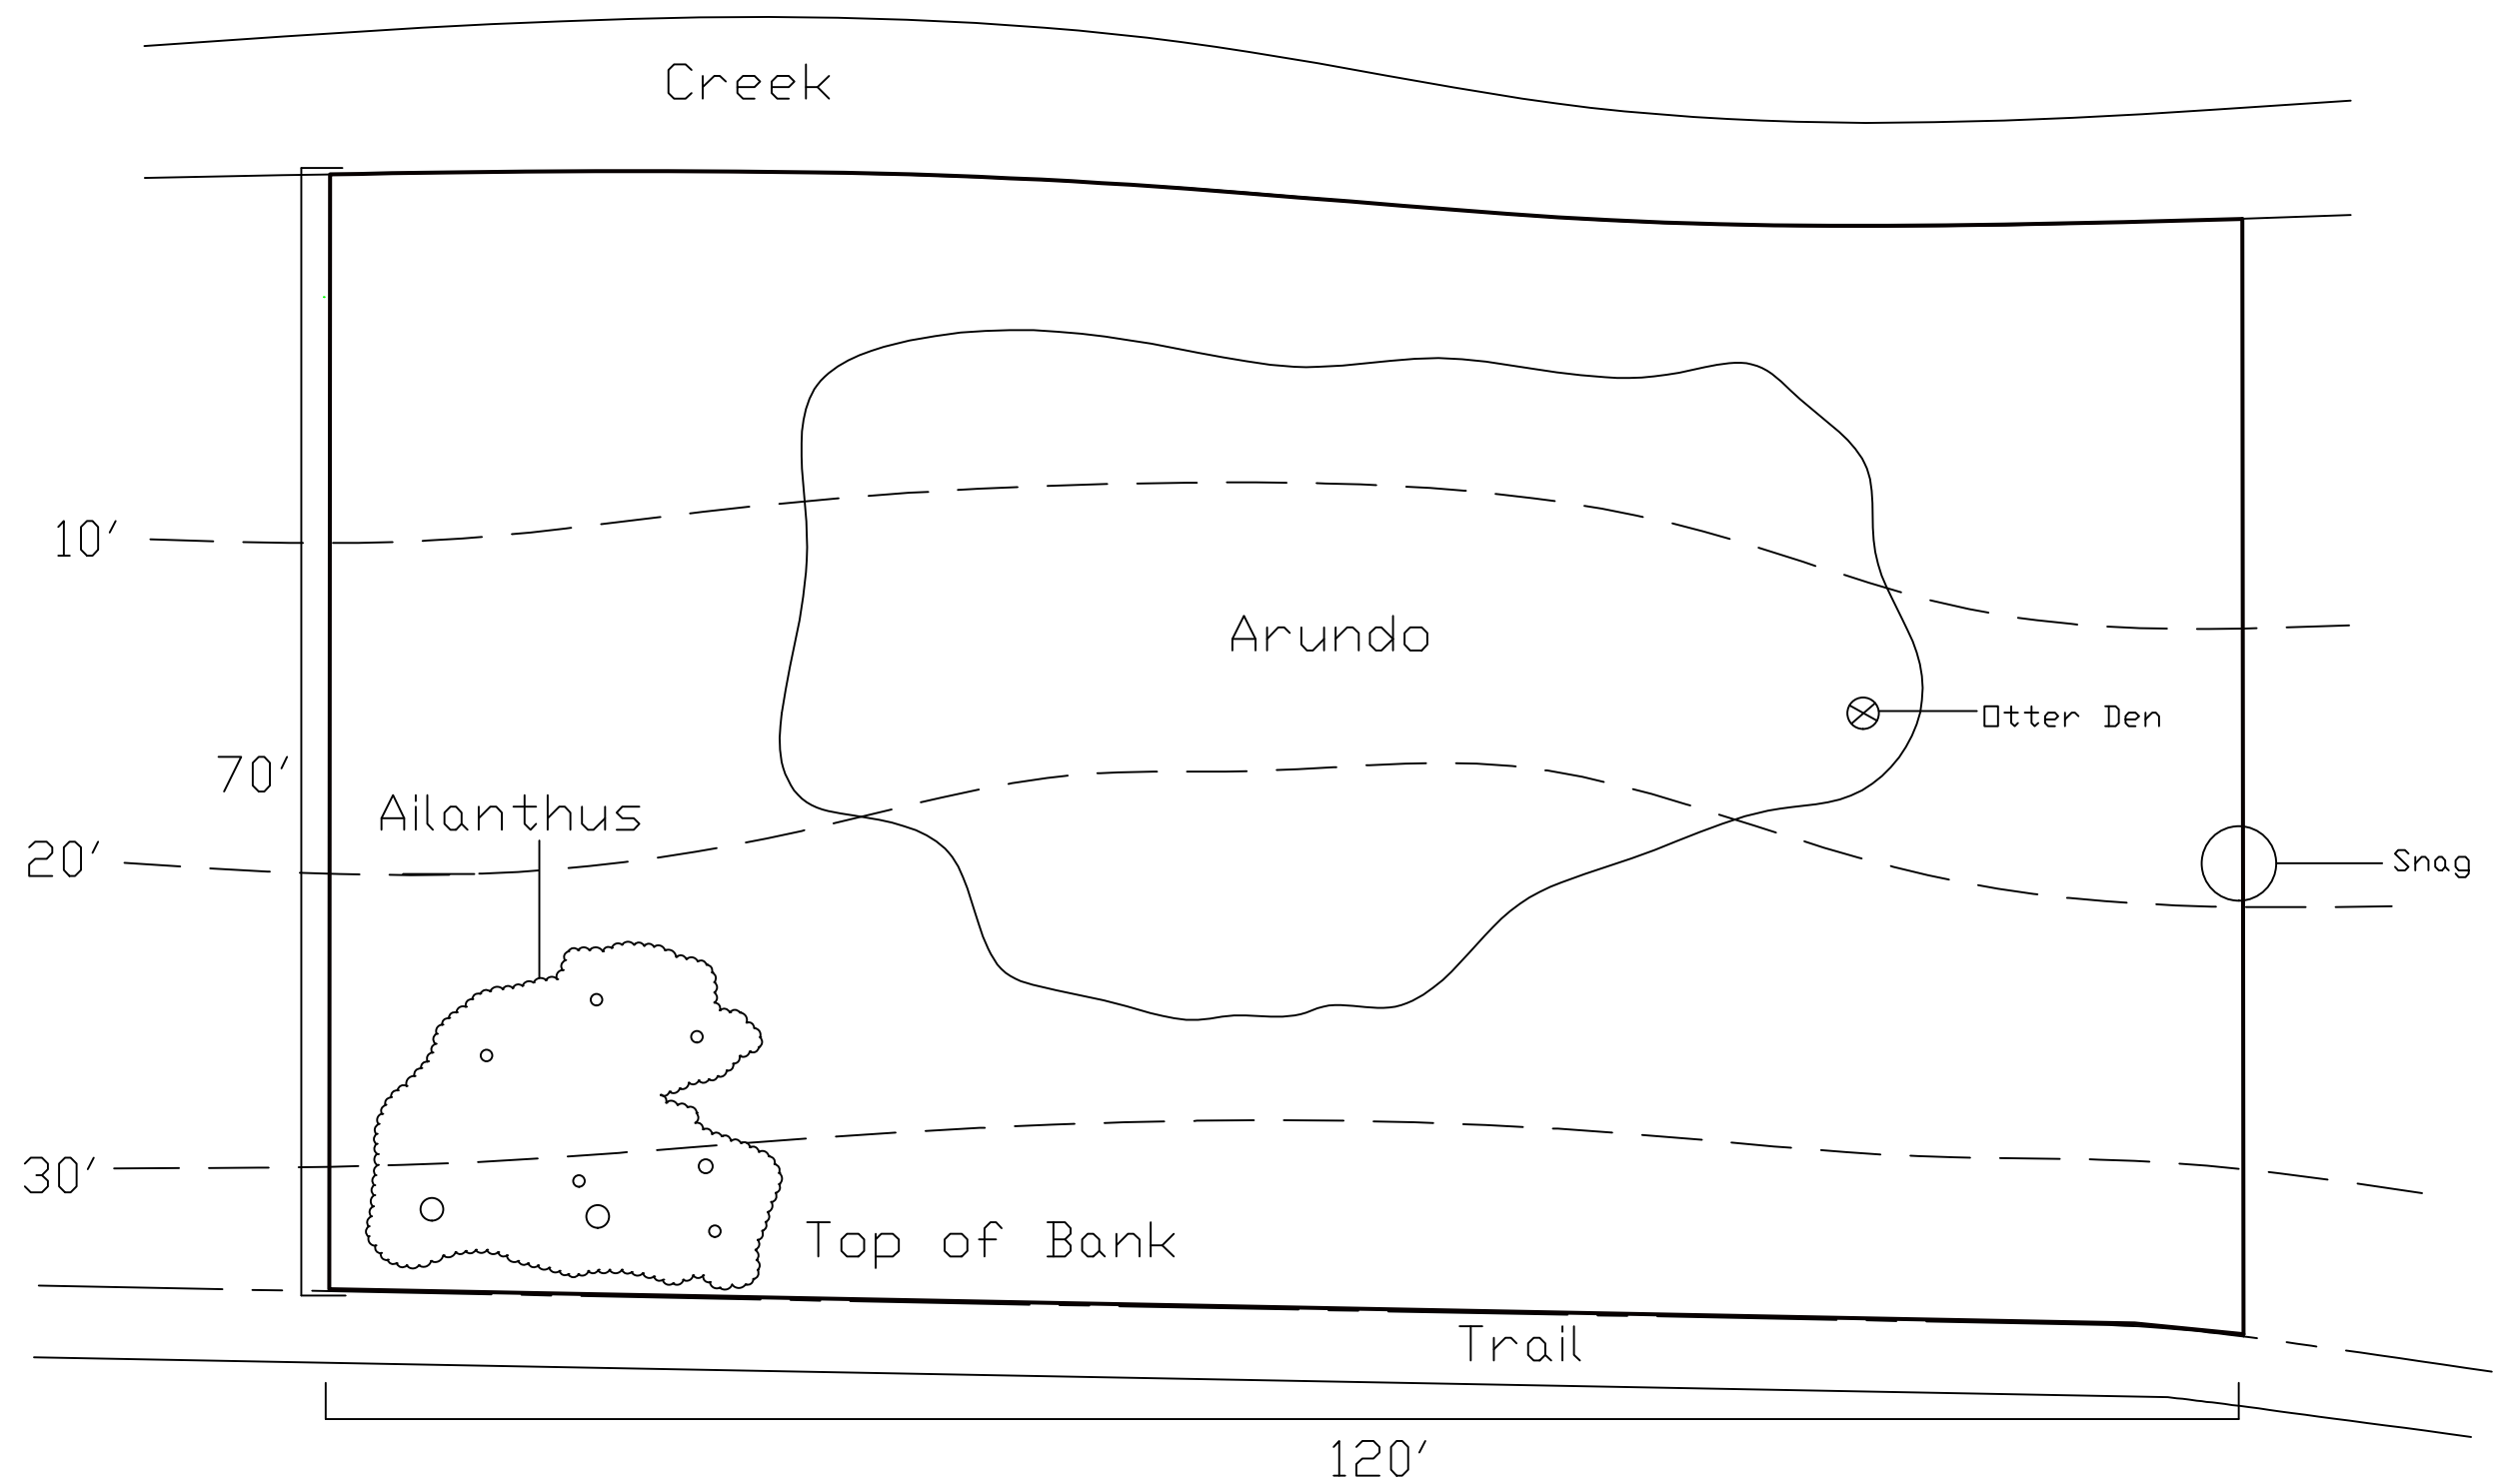
The San Ramon Creek site (see attached plan) occupies about 120 ft. of creek bank and is about 70 ft. wide, totaling about 8,600 sq. ft. The site is in Hap Magee Ranch Park, and a split-rail fence and trail demarks its upper boundary. An approximately 10 ft. wide nearly level terrace forms the upper edge of the site, and the remainder is a relatively steep slope down to the creek. The site was dominated by a large (60 ft. by 40 ft.) stand of Arundo that had been cleared once but grew back to its original extent (View 1). The site also had numerous tree of heaven saplings reaching up to 30 ft. in height, as well as dense cover of English ivy and periwinkle (*Vinca major*). The site was partially shaded by mature valley oaks (*Quercus lobata*) on its up- and downstream edges.

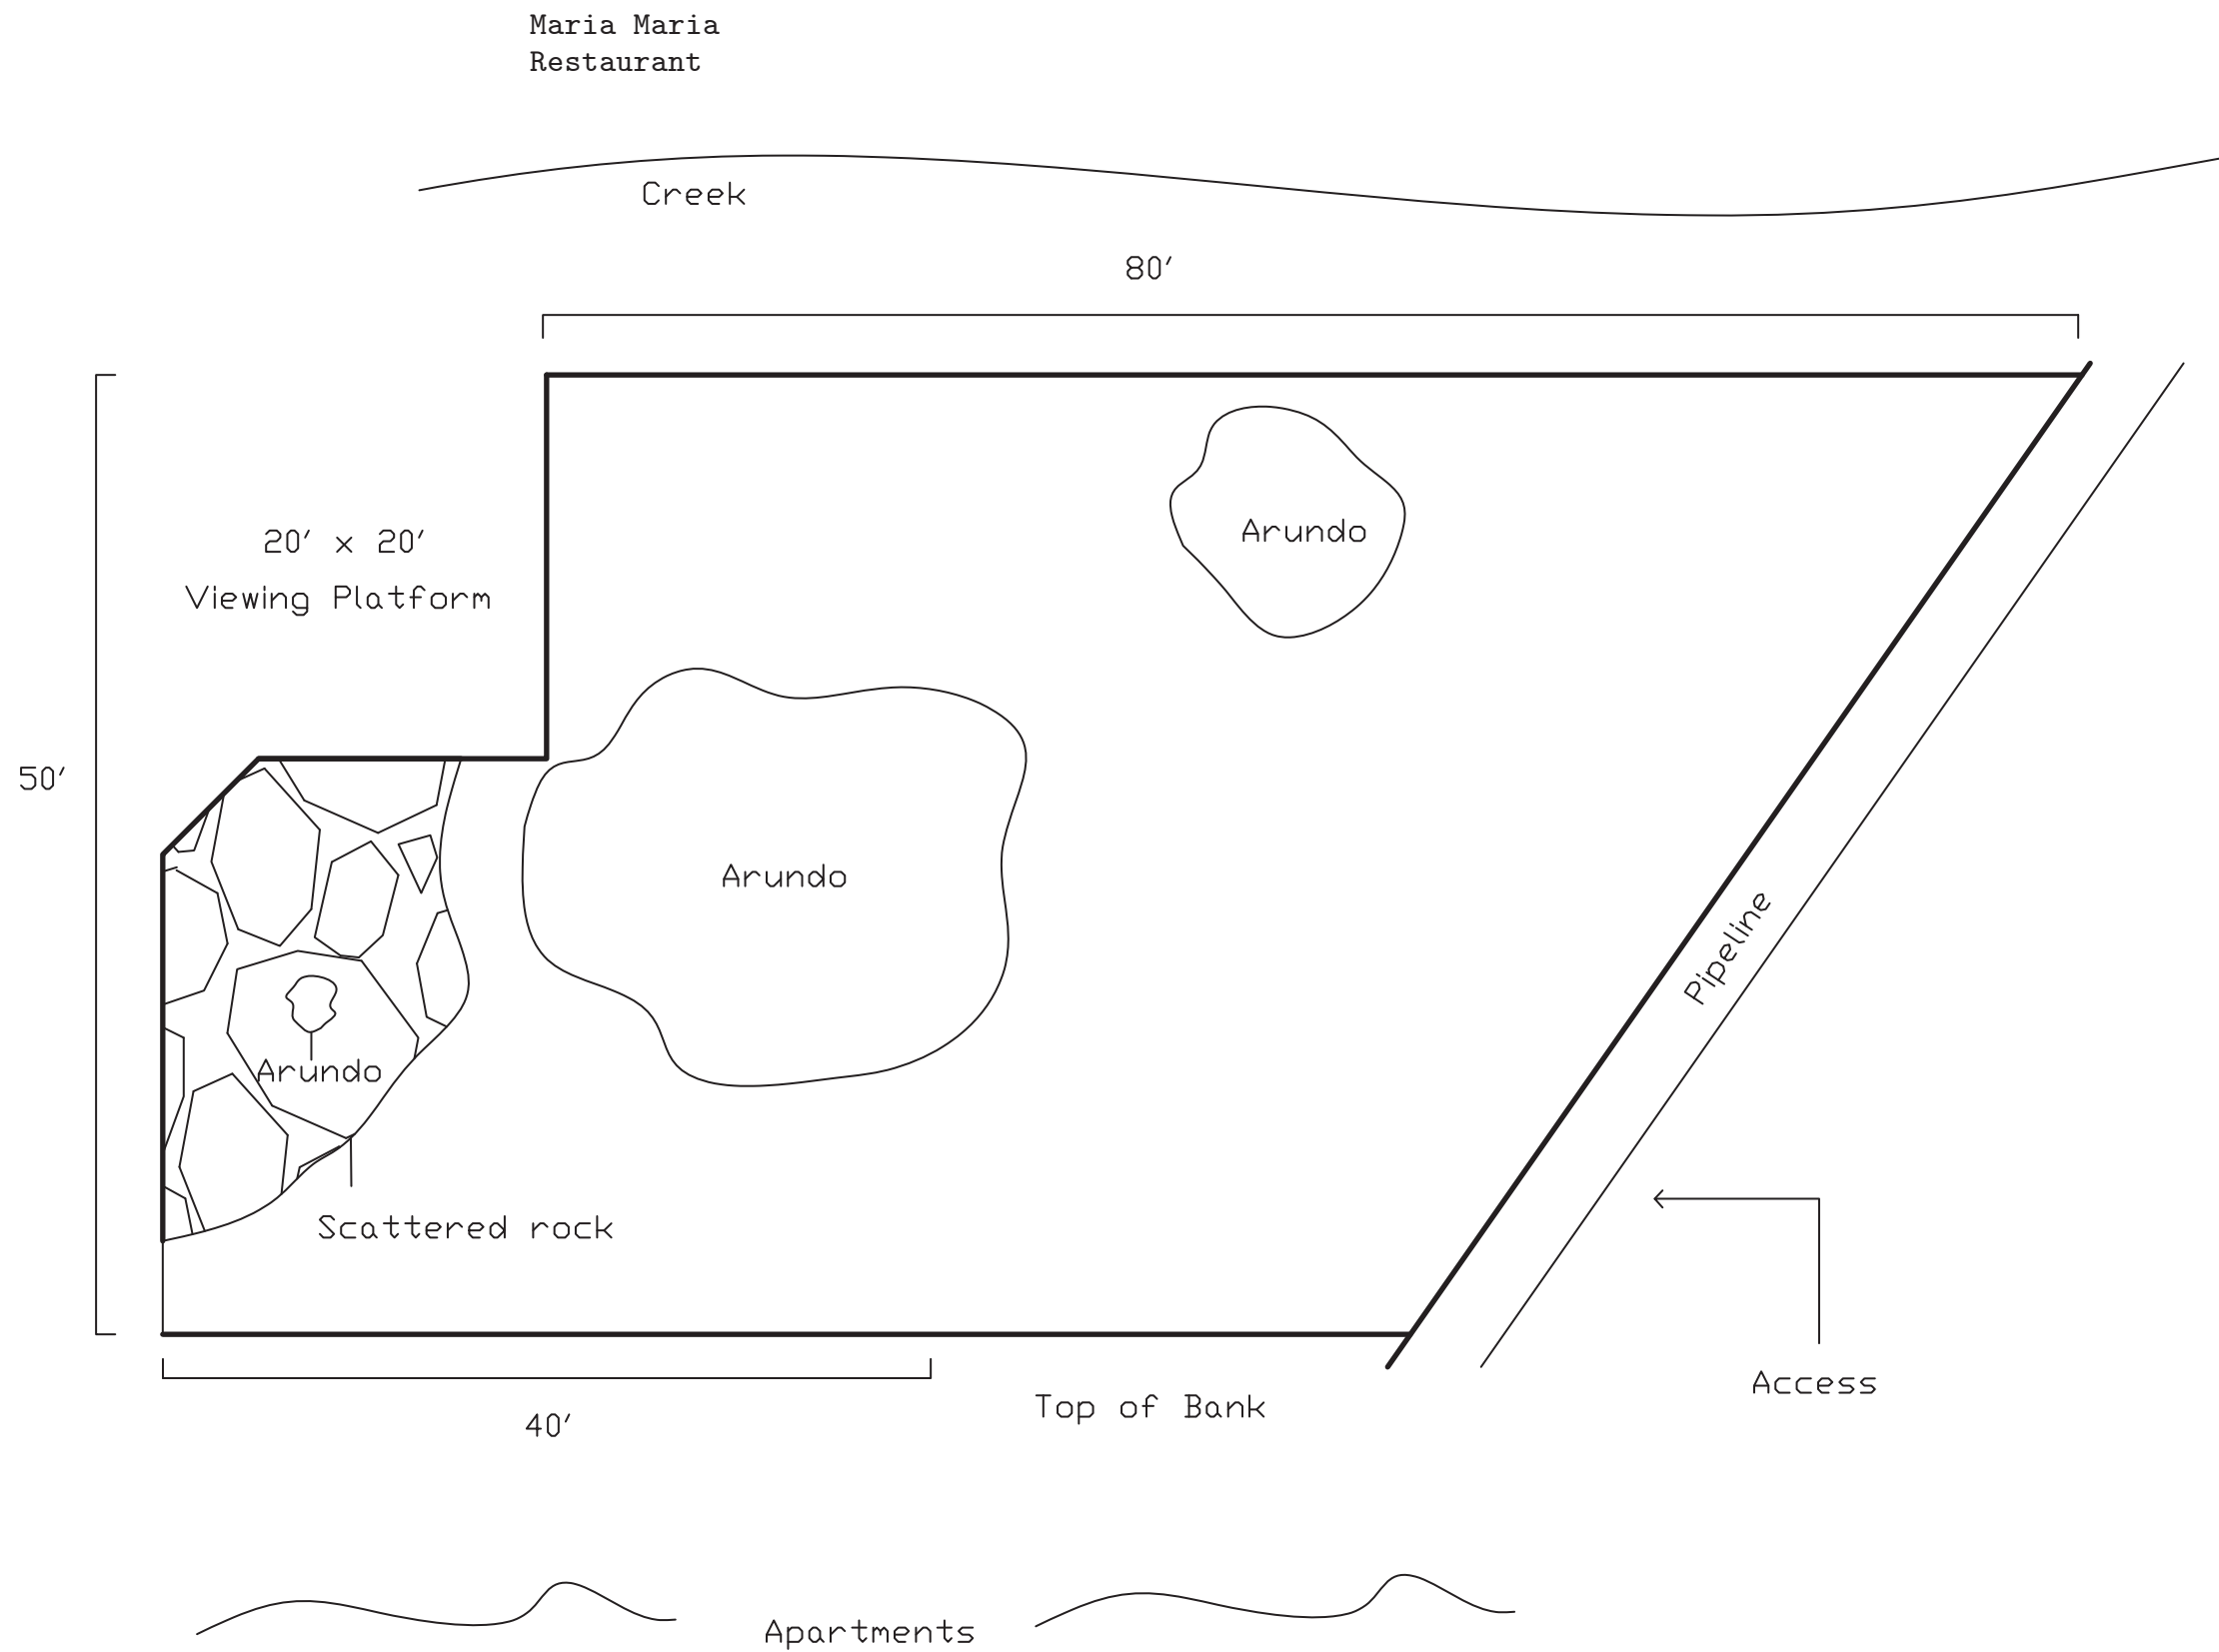
The site was dominated by two Arundo stands, one about 30 ft. by 30 ft. (View 4) and another about 15 ft. by 20 ft. The site was also carpeted with English ivy over a good amount of downed wood, making for treacherous footing. Numerous black locust (*Robinia*

pseudoaccacia) saplings were also found along the creek's edge. The site was partially shaded by mature Fremont cottonwoods (*Populus fremontii*) and several valley oaks.

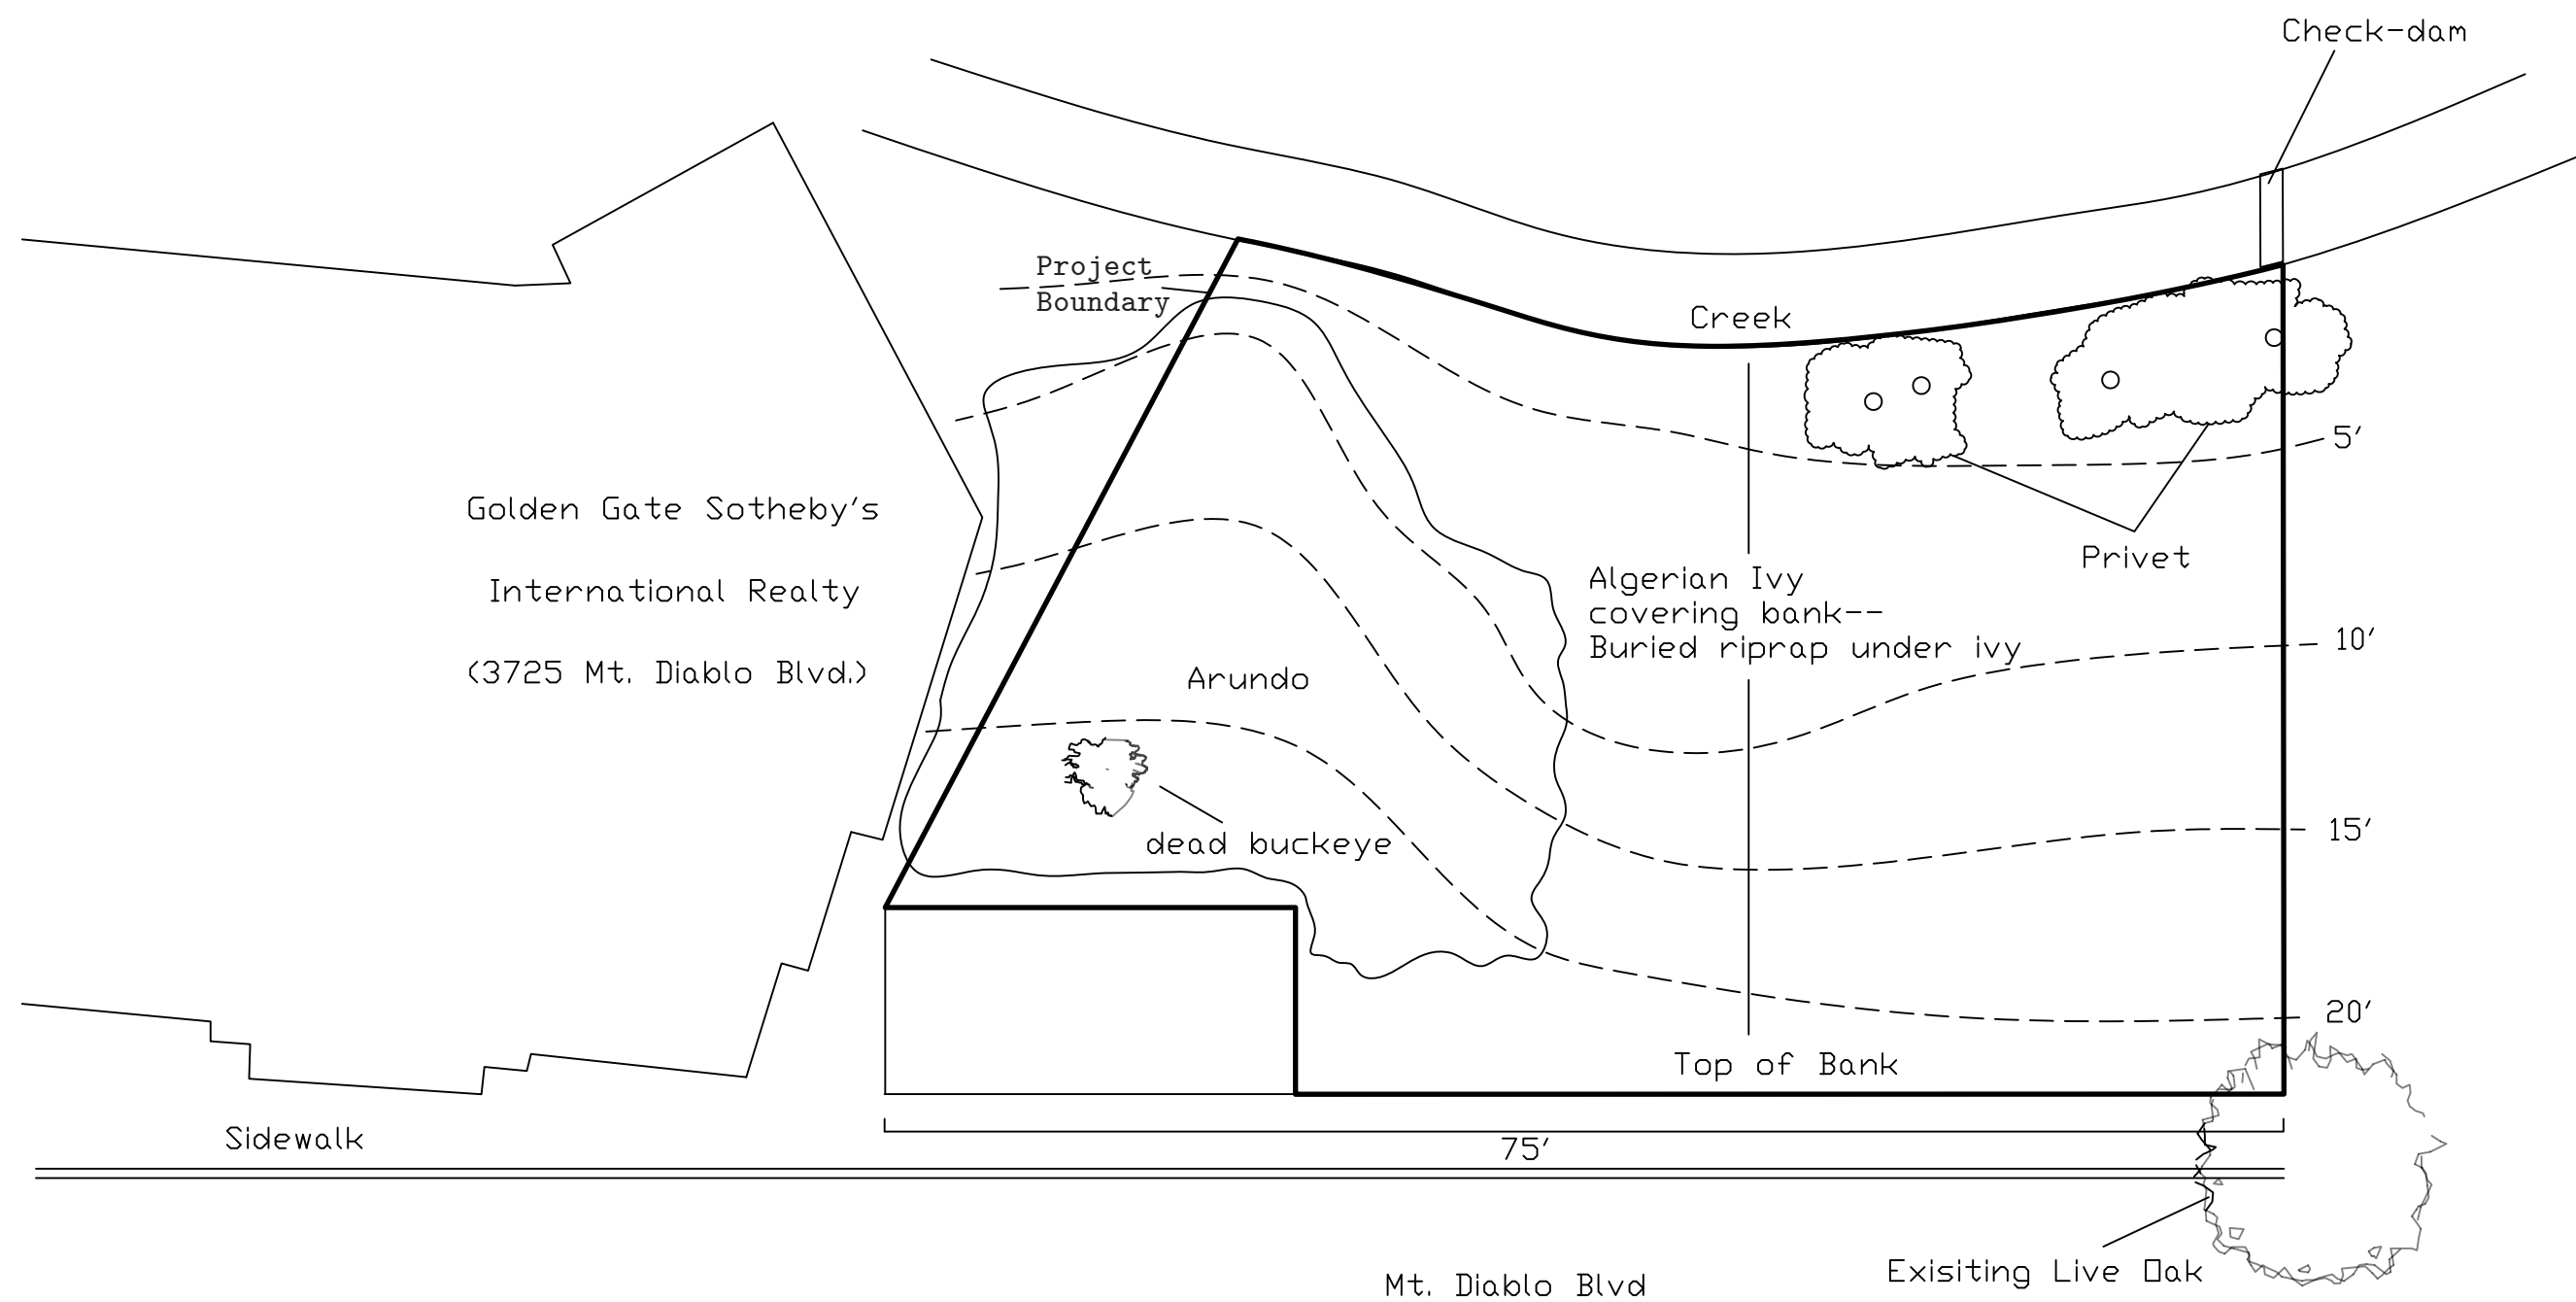
The Lafayette Creek site (see attached plan) occupies about 70 ft. of creek bank and is about 40 ft. wide, totaling about 3,000 sq. ft. The site is owned by the City and is integral to the City's downtown creeks system. The site has a relatively level terrace at its uppermost edge, but this is only about 3 to 4 ft. wide; next to that, it slopes gently down to the creek. The site was dominated by a large, dense *Arundo* stand (30 ft. by 30 ft.). The site was also heavily carpeted with English ivy and had a stand of mature privet near the creek (View 7). Like the previously described sites, shade was provided by mature native trees, in this case, coast live oak and California buckeyes (*Aesculus californica*).

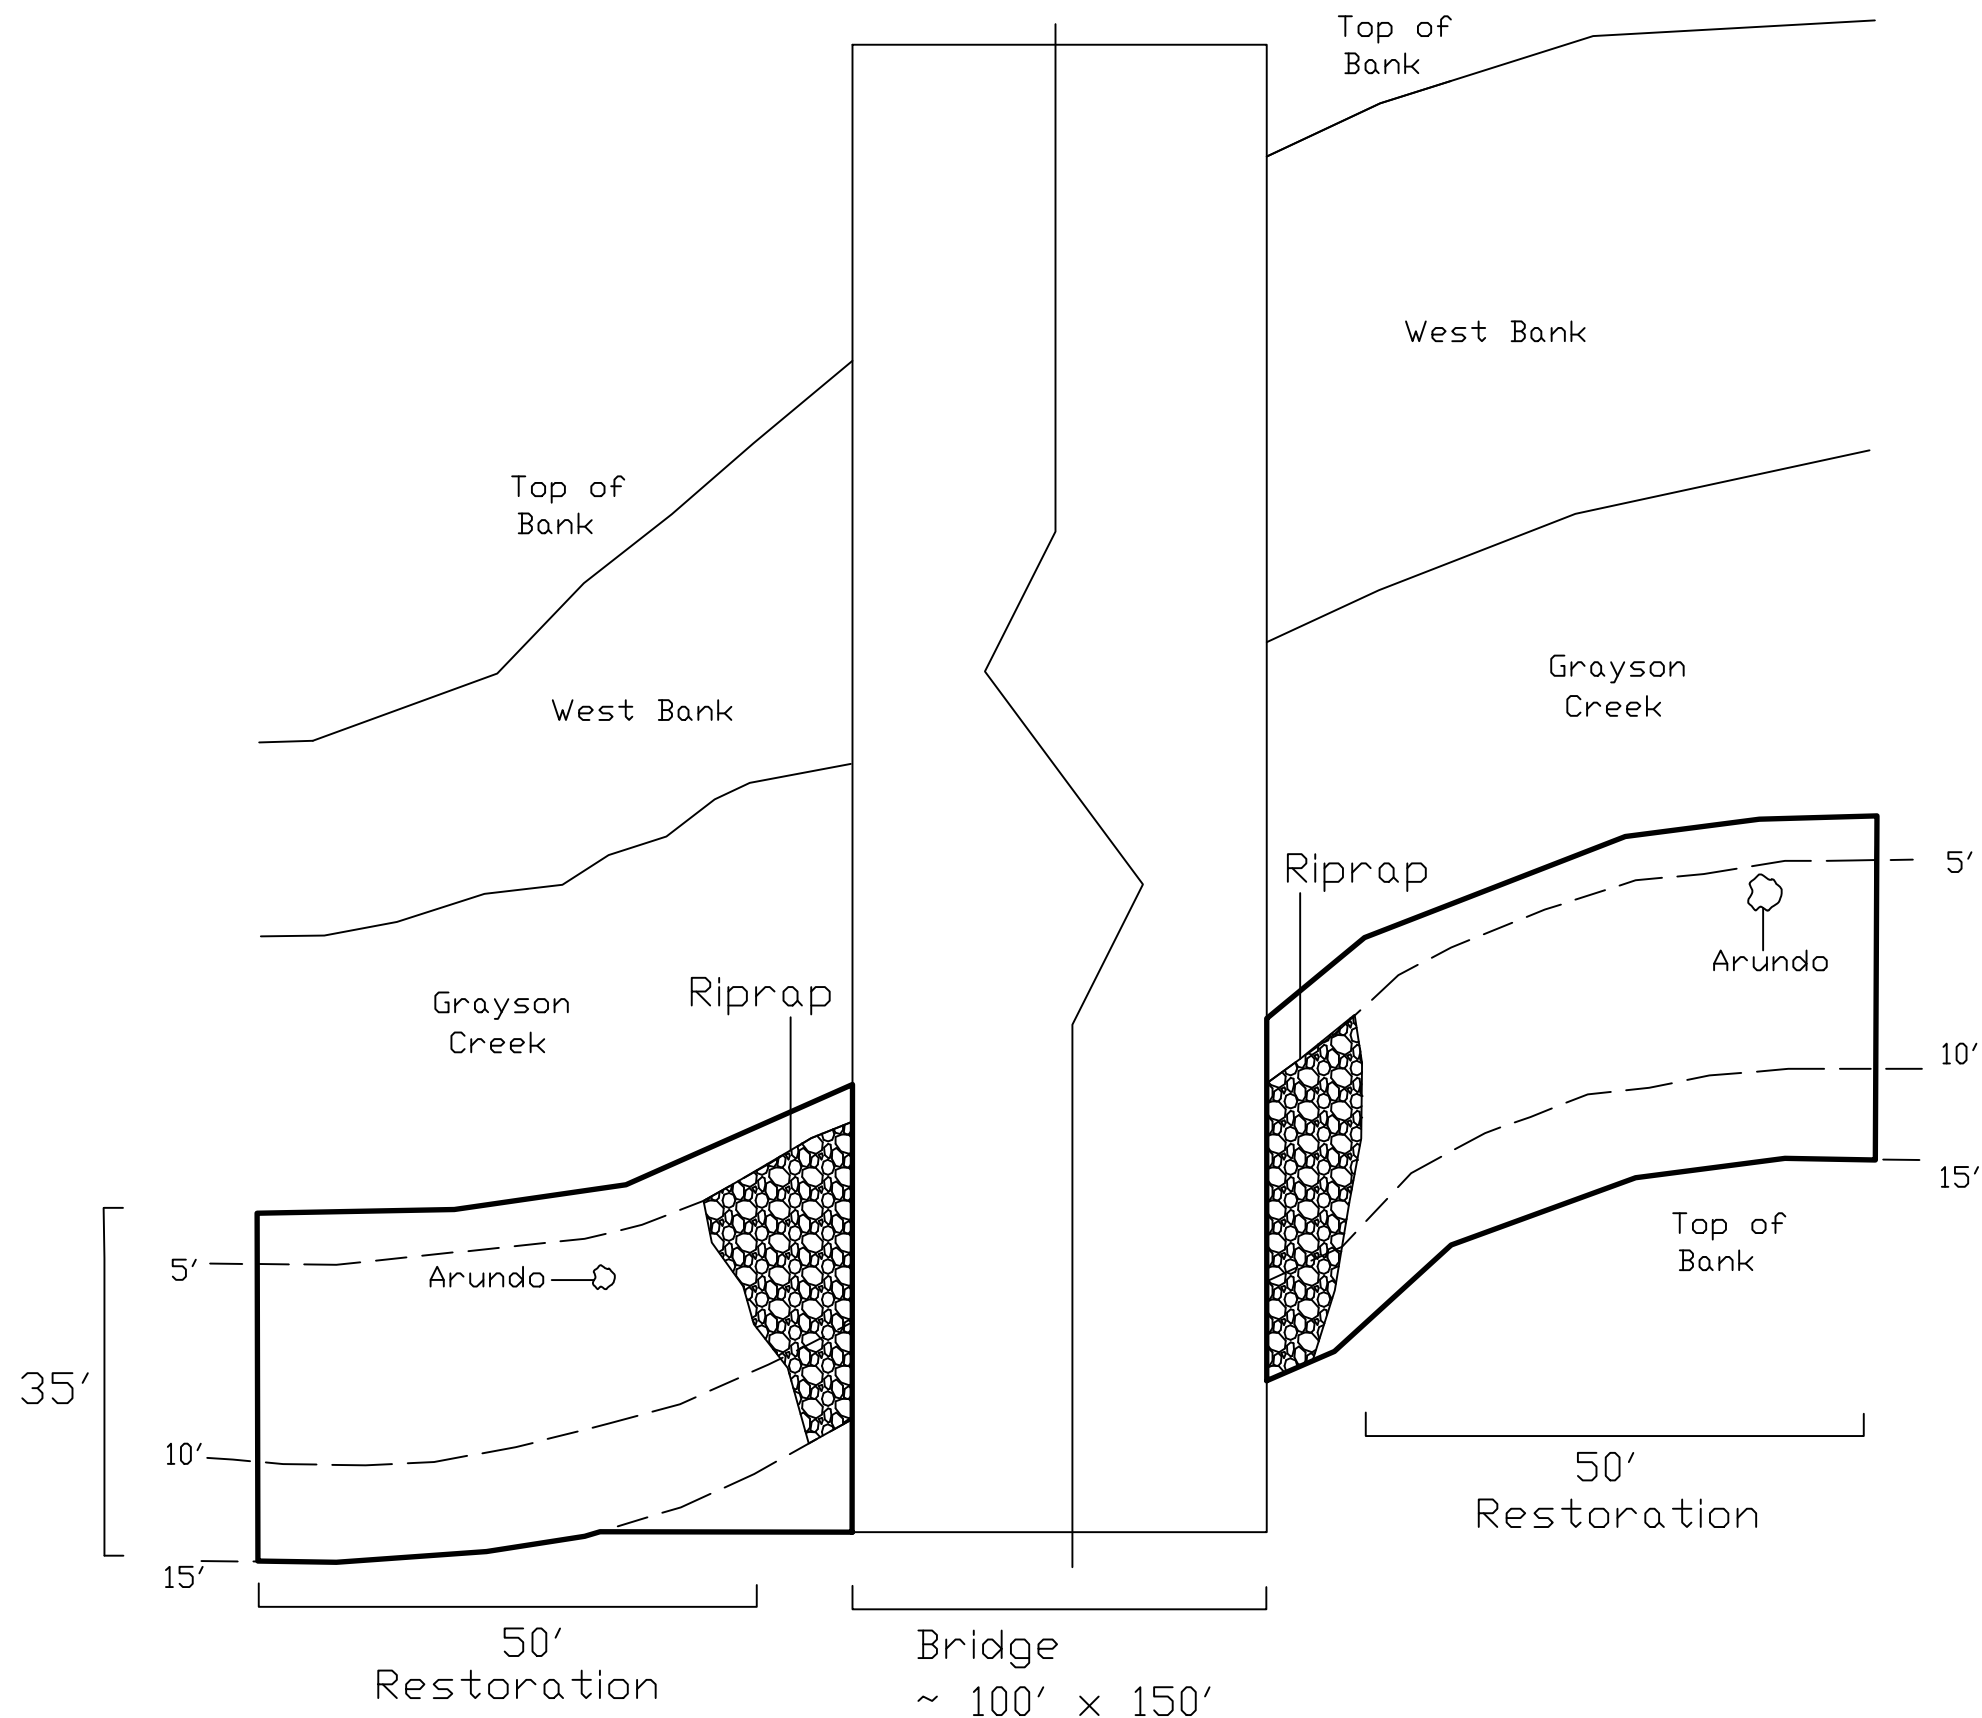
The site is owned by the FCD and is managed as a flood control channel. The site is open, with gently sloped, sunny banks with a gravel road atop the bank. Prior to our work, the site was dominated by a variety of non-native grasses and forbs with two small stands of Arundo—one on the north side and one on the south side of the GCR bridge. There are no trees or shrubs on this site as they are kept cleared by the FCD.
